February 23, 2023

Reference: Water Damage Causation Analysis – 34280 Capstan Lane, Rehoboth Beach, Delaware 19958

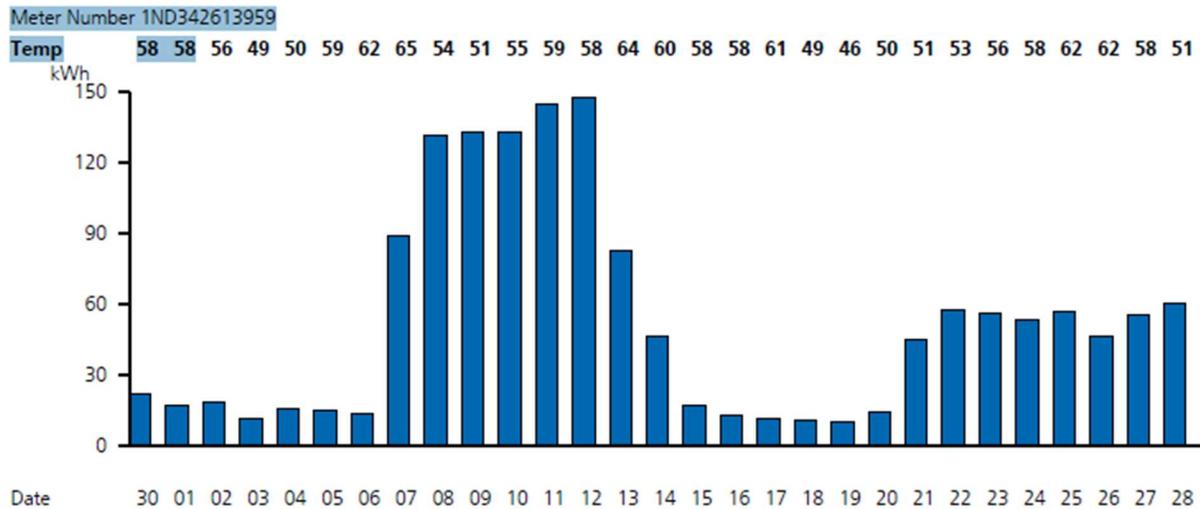
Document D-2 Electricity Usage Data Analysis

Electricity usage data indicated that the leak start during October 7, 2022, and continued into October 13, 2022, spanning 7 days. Recall that the GC installed the Kitchen sink, connected the plumbing to the sink and turned the water back on during October 7, 2022. The electricity usage on October 14, 2022, is likely associated with the leak check performed by Tidewater. An approximate electricity usage in excess of the norm for the period is about 120 KWH/day. If the water heater was able to continuously supply 120°F water with 70°F incoming water, the water flow would be about 0.68 GPM. Residential water heaters typically cannot sustain their discharge temperature continuously after the first tank inventory of water is depleted. For example, the following table lists the calculated hot water flow rate as a function of the sustained hot water discharge temperature:

Baseline Electricity Usage	Hot Water turned on beginning 10/7 and shut off 10/13. Tidewater leak testing on 10/14	Baseline Electricity Usage	Drying and HEPA air filters in operation
----------------------------	--	----------------------------	--

Note – An analysis of the approximate maximum peak daily electricity usage for 2021 through September 2022 was 75 KWH (May 2021). Baseline periods (likely periods when the house is unoccupied, and the heating and air-conditioning did not operate much) had peak daily electricity usage in the range of 11 to 20 KWH. This daily electricity usage is consistent with the data just preceding and following the water leak event. The daily electricity usage in the range of 140 KWH cannot be explained by the sum of normal usages, such as, lighting, washing, heating and air-conditioning, refrigeration, and water heating.

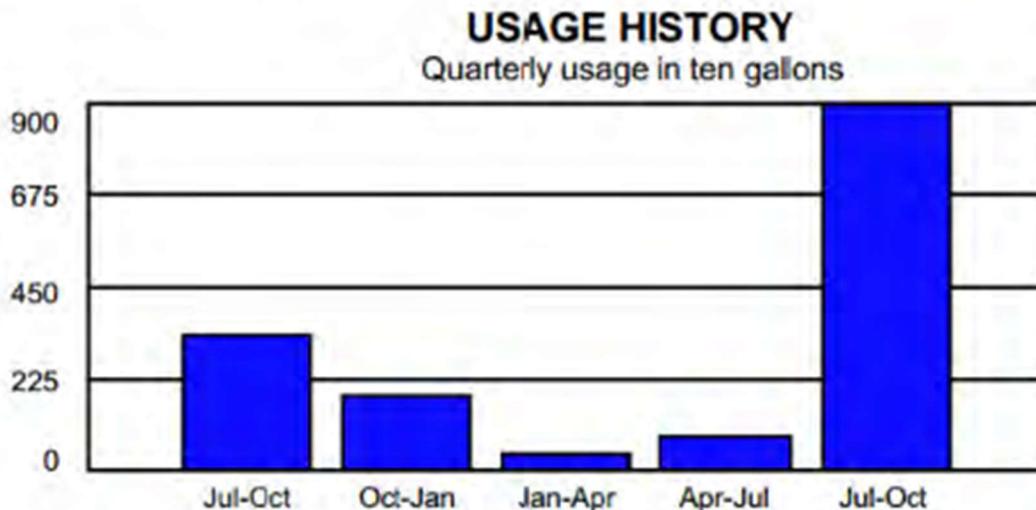
D-3 Water Usage Data Analysis

Unfortunately, the water usage data is recorded on a quarterly basis. An approximate water usage in excess of the norm for the period of interest is about 7,000 to 8,000 gallons per quarter or 0.7 GPM to 0.8 GPM respectively if the leak occurred over a 7-day period, and 0.8 GPM to 0.92 GPM over a 6-day period respectively.

Note – Unfortunately, the water usage data is presented on a quarterly basis. The July through October 2022 usage is clearly inconsistent with the expected usage based on previous periods. Fortunately, the electricity daily usage pattern records a similarly low electricity usage except for the peak usage when hot water was leaking over about a seven-day period. This establishes that the extraordinary water usage during the July through October 2022 quarter likely occurred during the leak period.

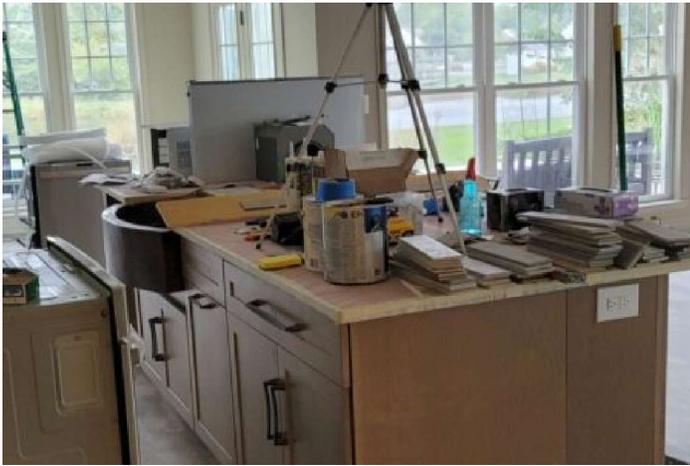
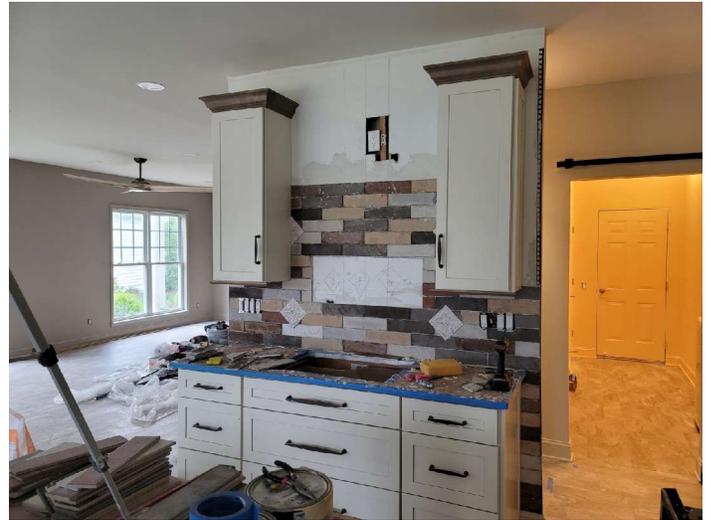
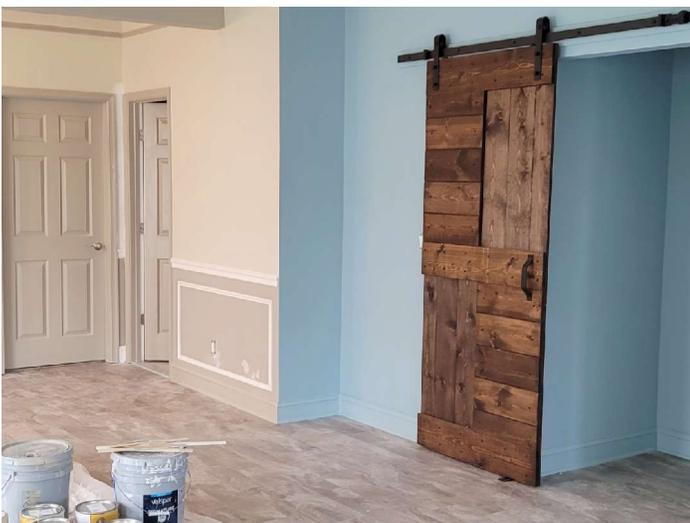
P-1 House Conditions Before the Water Leak

Based on information provided by the Owners and GC, the refurbishment project was proceeding along a normal path, with many of the activities nearing completion. Attachment P-1 records the conditions in the house prior to the detection of the water damage. Up until the time of the occurrence, there were no indications the floor slab had been previously exposed to water.

The following photographs document that the house refurbishment project was nearing completion at the time of the water leak.

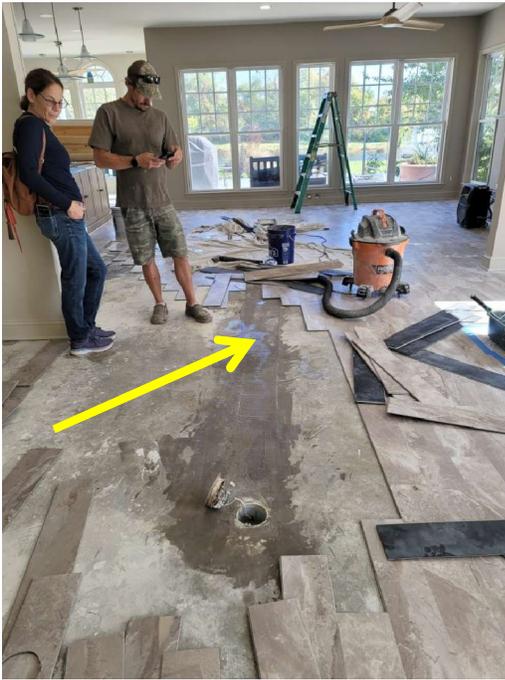
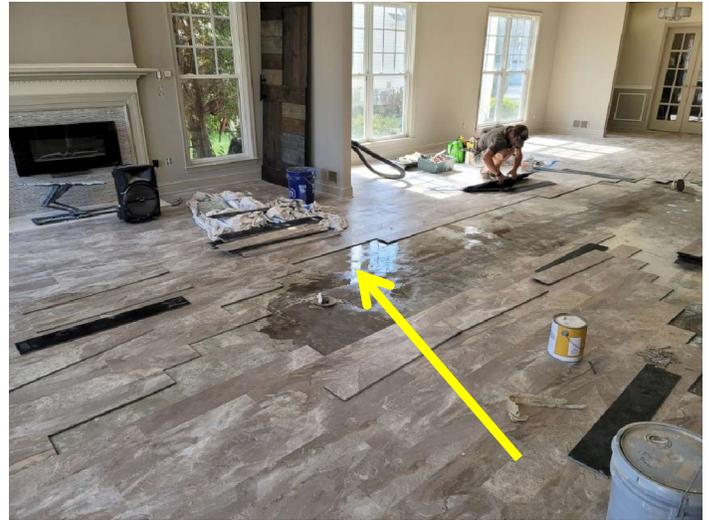
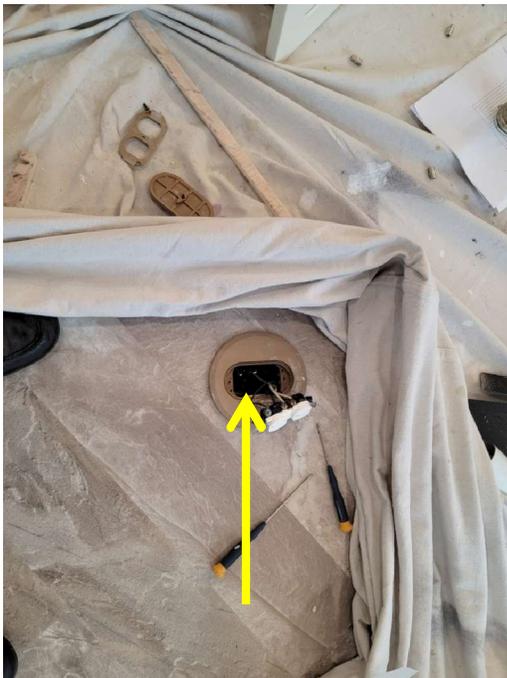
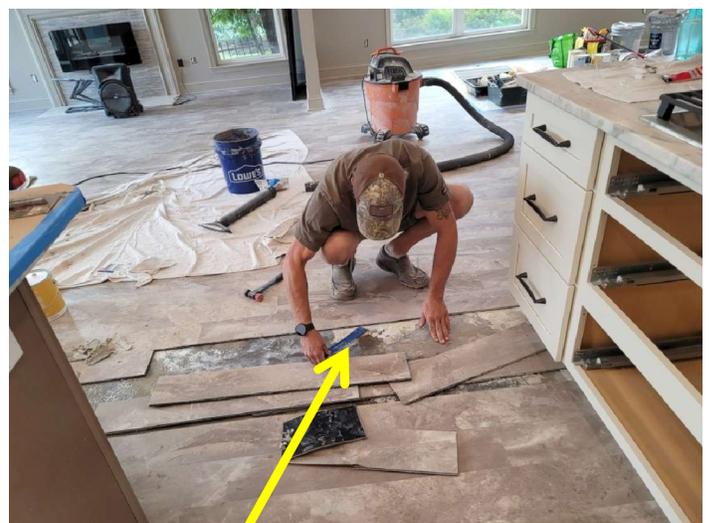
P-2 The Leak Was Detected on October 13, 2022

On October 13, 2022, the flooring sub-contractor reported to the GC that he found water on the vinyl plank flooring in the area of the Kitchen Island. The GC then found water under the vinyl plank flooring in the hall behind the stove area. See Attachment P-2. Plumbing and electrical openings in the floor slab area nearby this location were filled with water.

Efforts to find the leak source and the extent of damage followed beginning on October 14, 2022. Water was present under the vinyl plank flooring in many places. Note water on the floor.

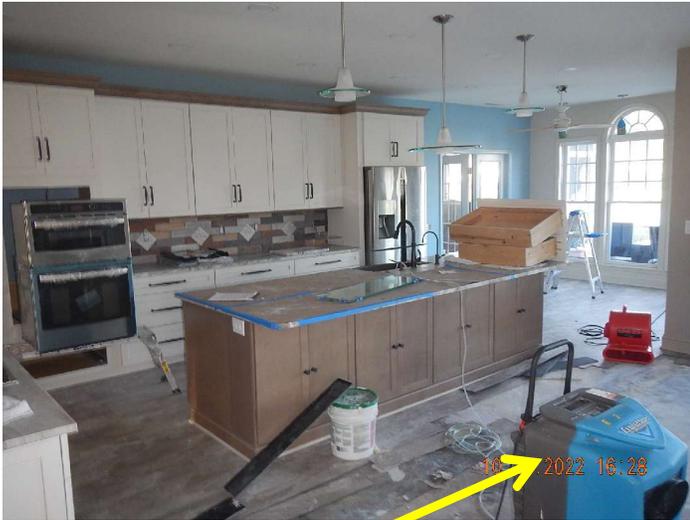
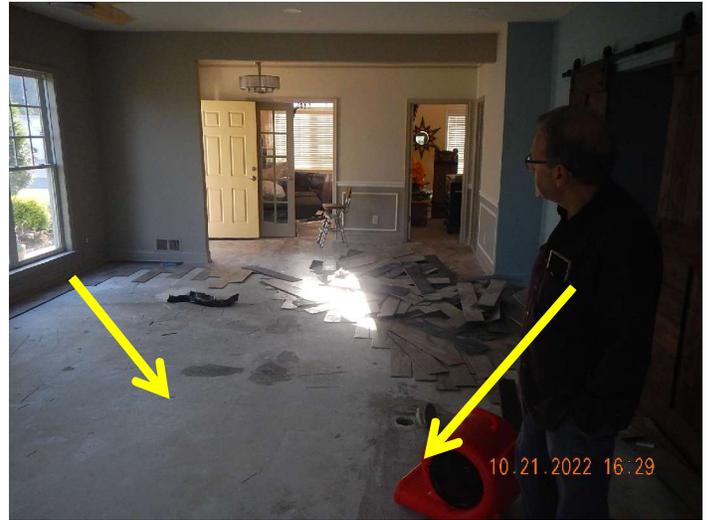
P-3 Cogent First Visit

On October 21, 2022, Cogent started a series of visits to the Property to first stabilize the situation to assure that ongoing damage was held to a minimum. As seen in Attachment P-3, efforts had already started to find the leak source and define the extent of damage. Information was then collected to establish the extent of the water damage and to consult with Core24. Core24 provided the means, methods, materials, manpower and supervision to perform the work. Concurrently, Cogent collected information to identify the water leak source. Note that QBE supported the Owner's decision to retain Cogent, as their leak detection company could not respond in a timely manner.

Cogent first visited the Property on October 21, 2022, observed areas where leak detection efforts had started and where the restoration was in the initial phase.

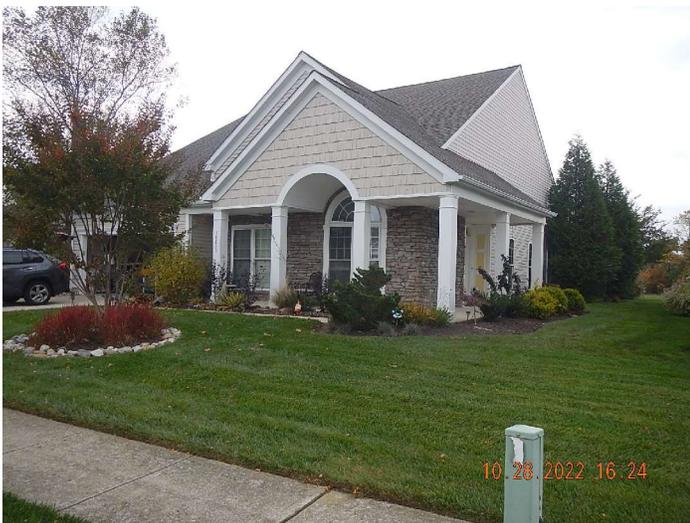
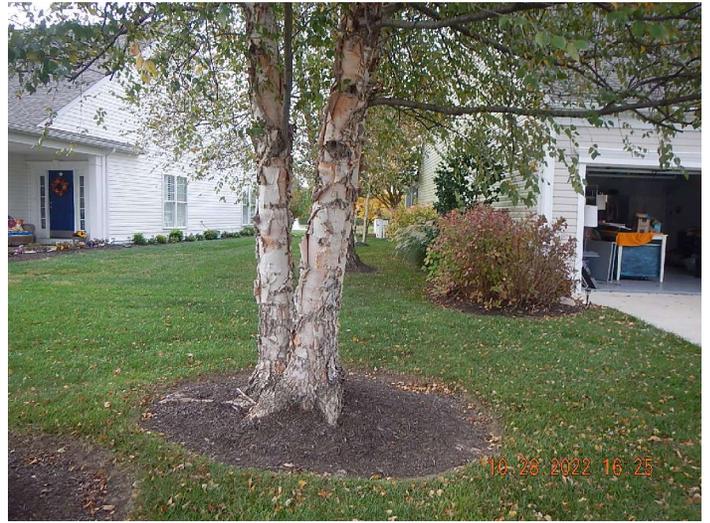
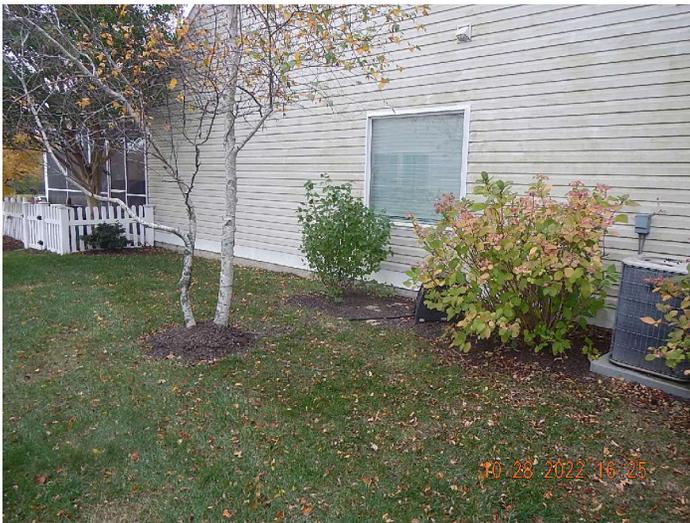
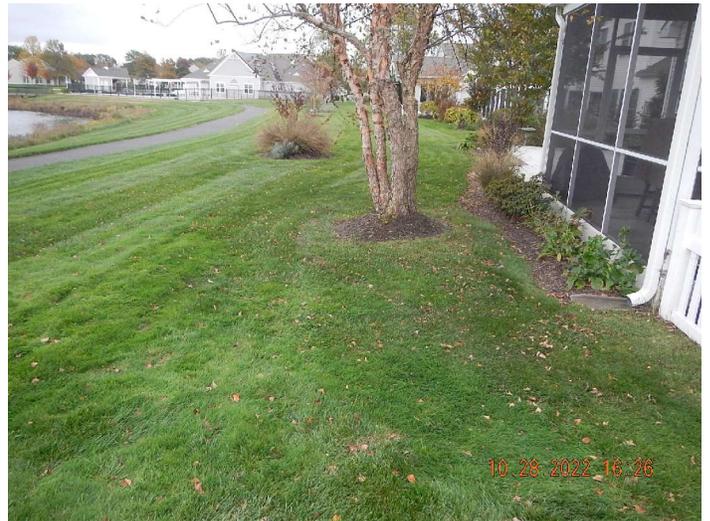
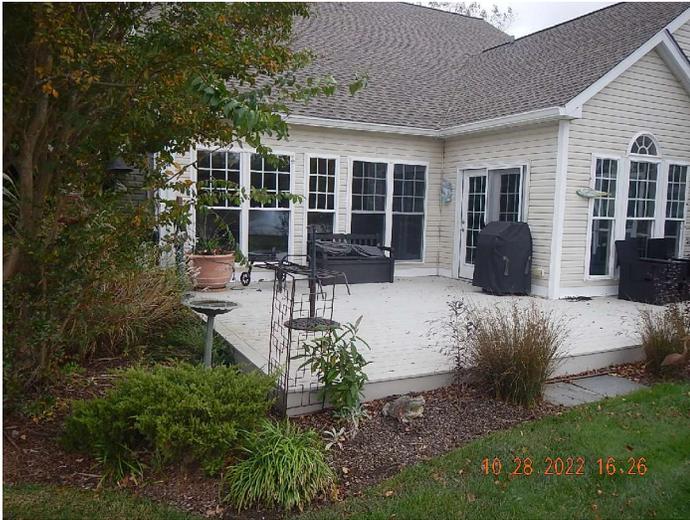
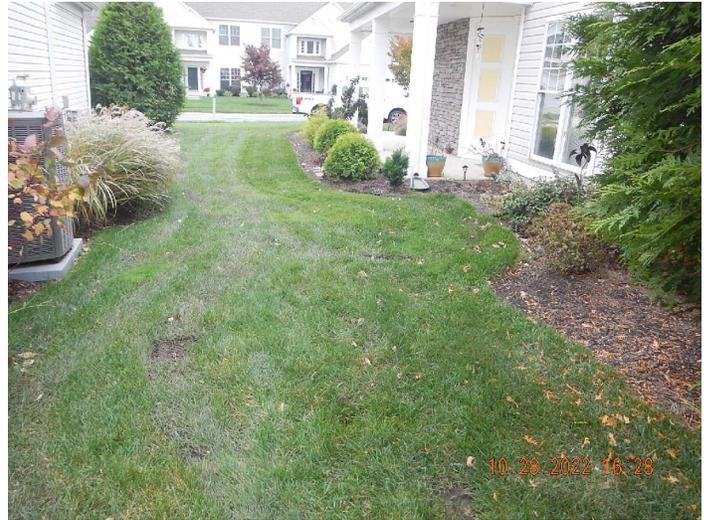
P-4a Exterior of the House

There were no indications that a flood had occurred around the house. The ground was sloped to encourage positive drainage away from the house.

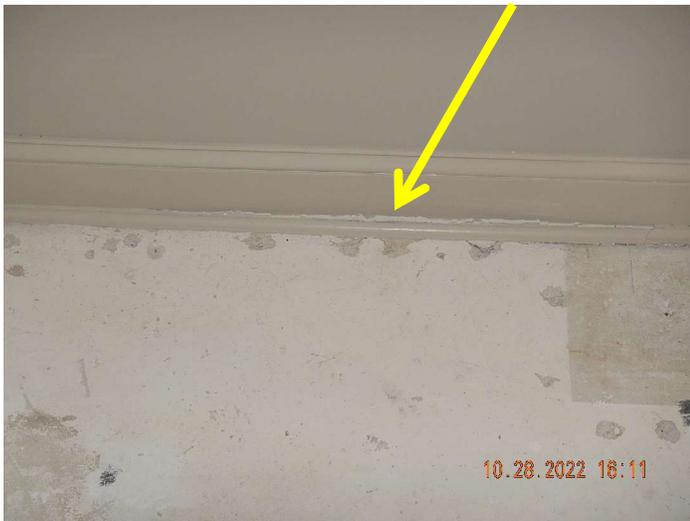
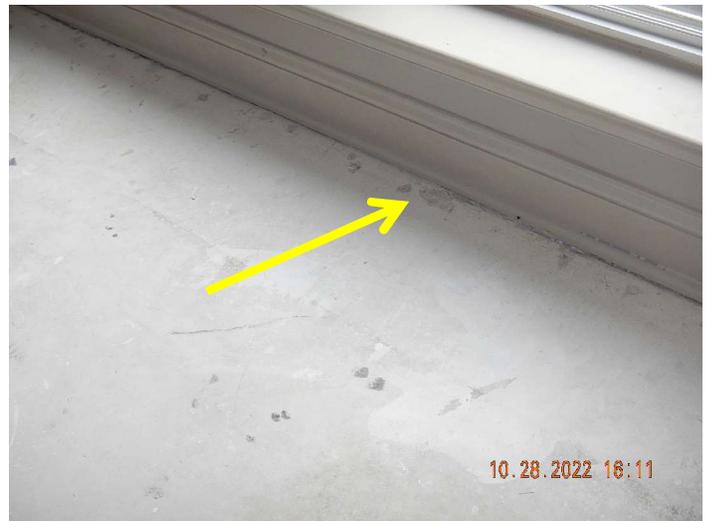
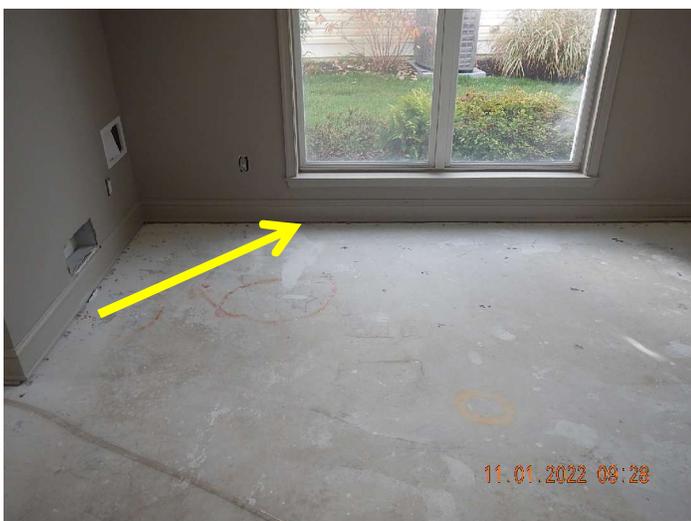
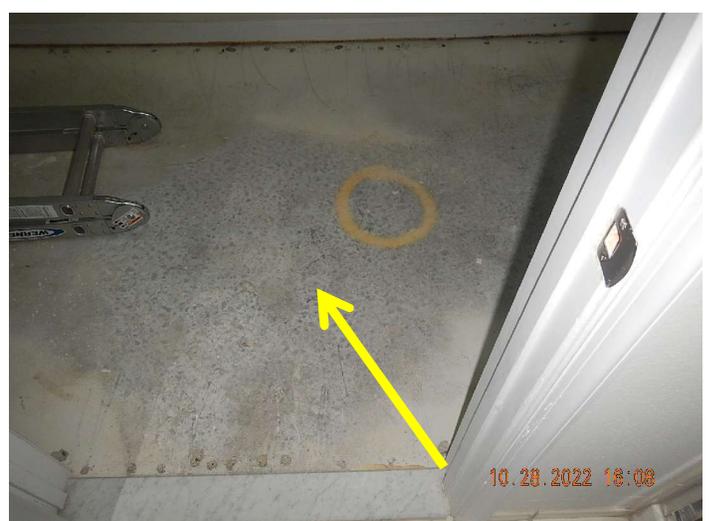
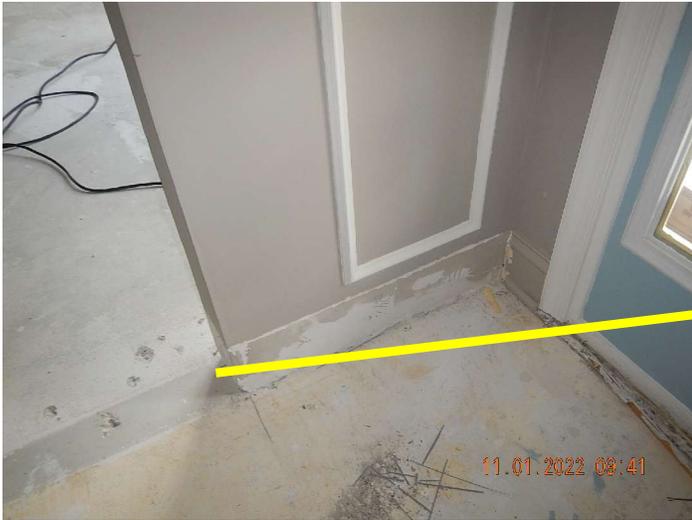
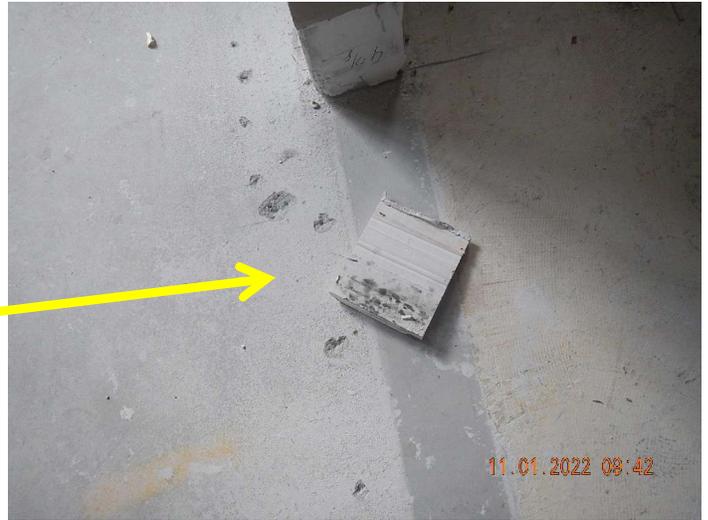
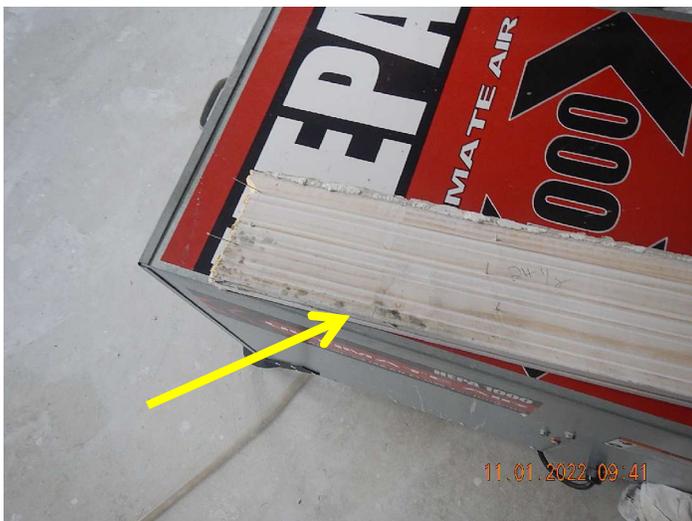
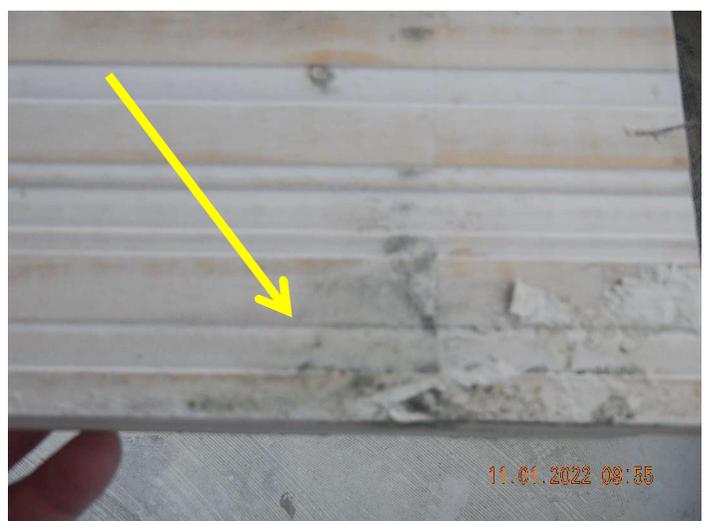
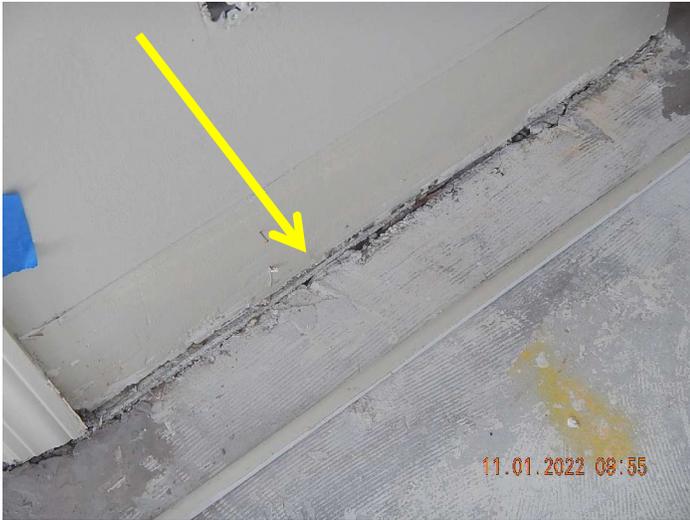
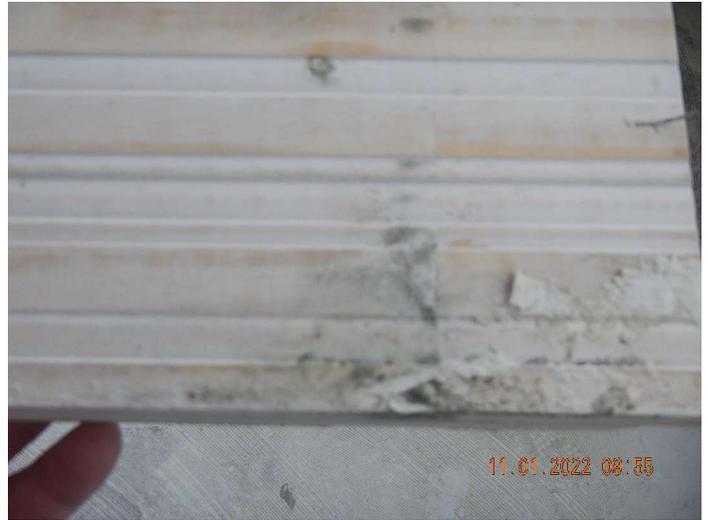
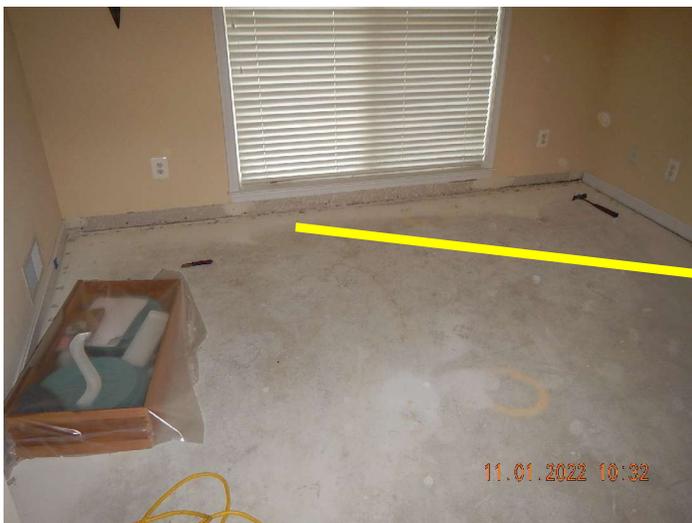
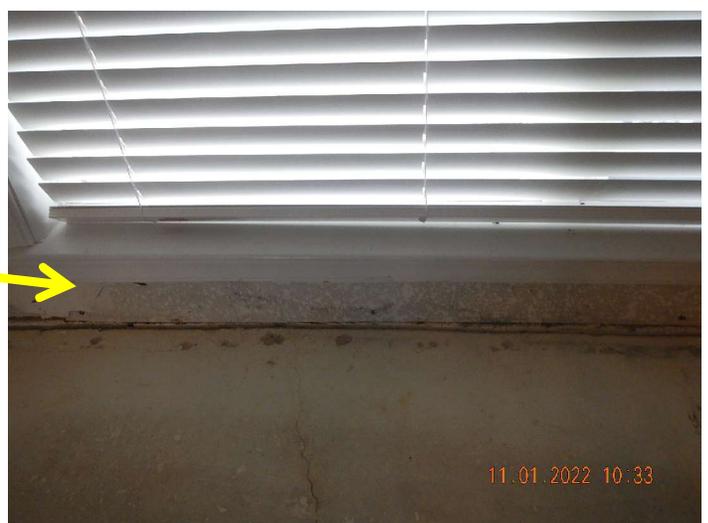
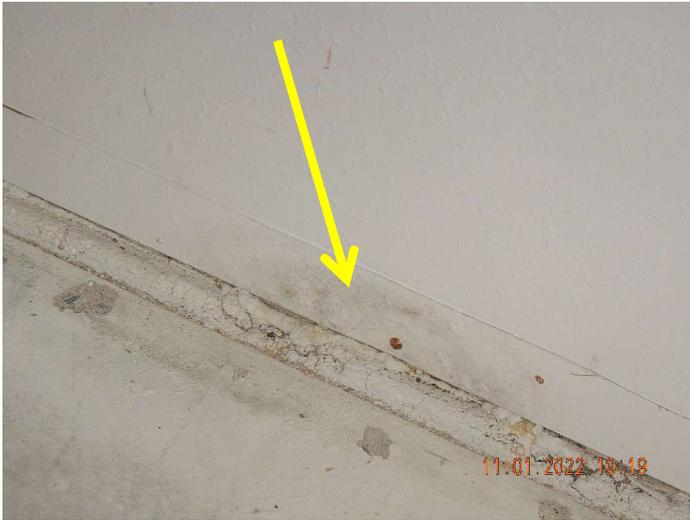
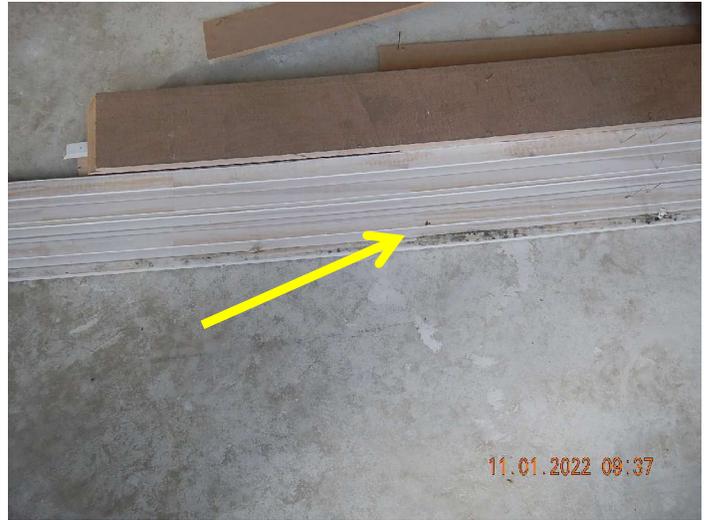
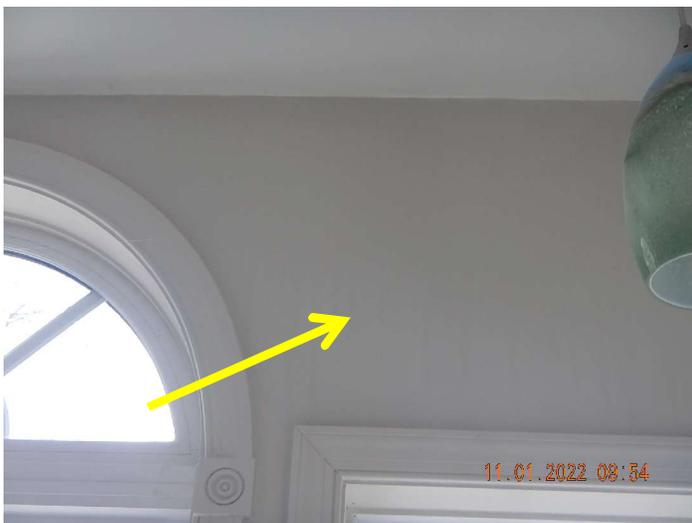
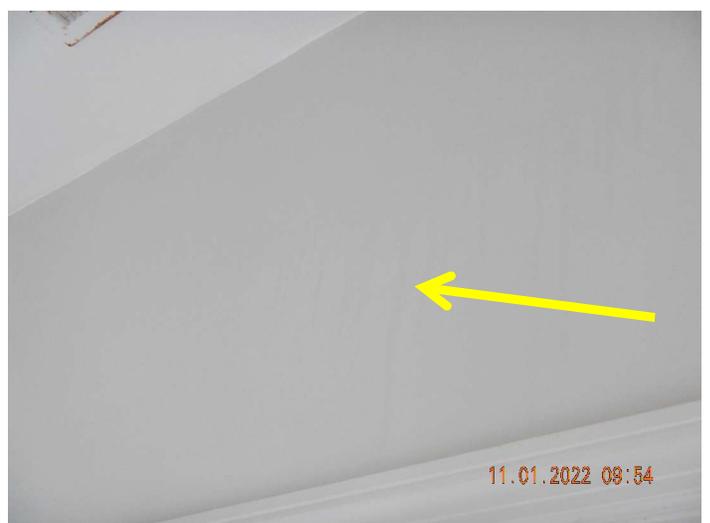
P-4b Surface Observations of Water Damage and Suspected Mold Growth

Cogent evaluated the water damage, as seen in Attachments P-4a through P-4g. Core24 found the carpeting in the Bedrooms and Library were thoroughly wet. Water stains and suspected mold growth was observed scattered along all exterior walls and many interior wall locations on both the baseboard trim and drywall at the bottom of the walls. Note that the term "suspected mold" is a term commonly used when a darkened or stained area on a surface has the appearance of mold and is present in an area with environmental conditions supportive of mold growth but has been identified as mold by an accredited microbial laboratory analysis.

The baseboard trim and wall base plates were observed to be water stained in many locations around the house. This variation along a given wall is likely attributable to normal irregularities in the flatness of concrete floors. With water exposure that is not deep, some wall areas stay dry while other areas experience prolonged water exposure. Cogent reviewed these findings with Core24. The standard in the water damage restoration/mold abatement industry is to remove and discard 18" to 24" of the drywall and wall insulation above the highest water mark. The sill plate, studs and sheathing were treated by Core24 for mold, by methods that includes sanding to

Observations made at the Property are typical for a water damage occurrence. Observations were present throughout the house and included, water stains, damaged drywall, suspected mold growth, swollen wood, paint damage and rusty nails, for instance.

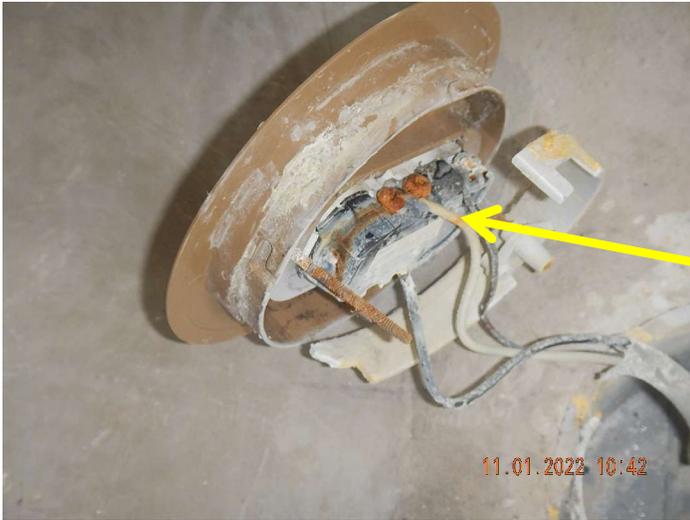
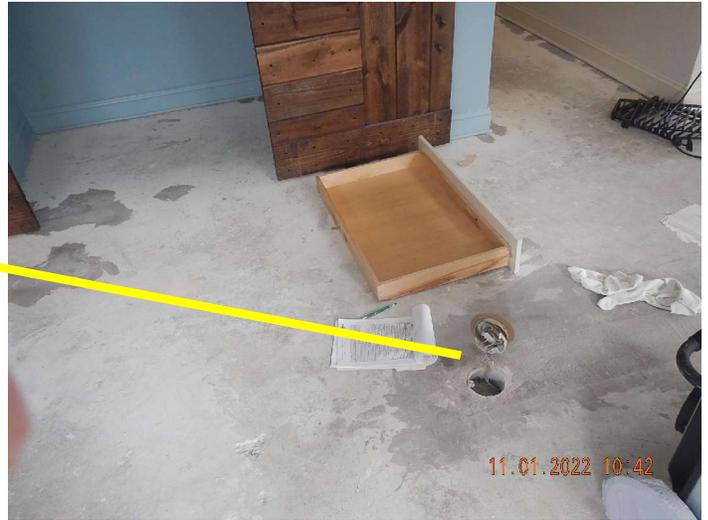
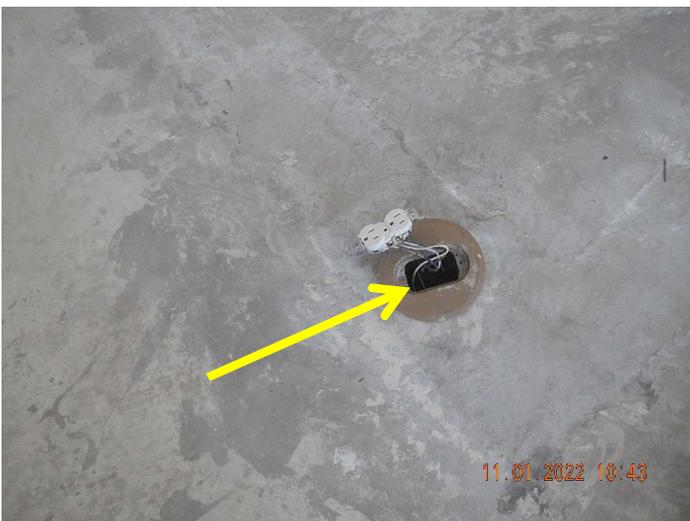
P-4c Water Exposure in Slab Electrical Receptacle

Areas where the floor slab had been removed to facilitate plumbing and electrical modifications were plainly evident, based on the color of the concrete. The electrical receptacle in the new floor outlet boxes were observed to be heavily corroded indicating that these new receptacles had been recently exposed to water. This finding also supports that a floor water exposure event had occurred and was present for some period of time.

Standing water in the slab receptacle boxes was observed by the GC when the water leak was discovered. The new electrical receptacles were found to be corroded indicating direct water exposure.

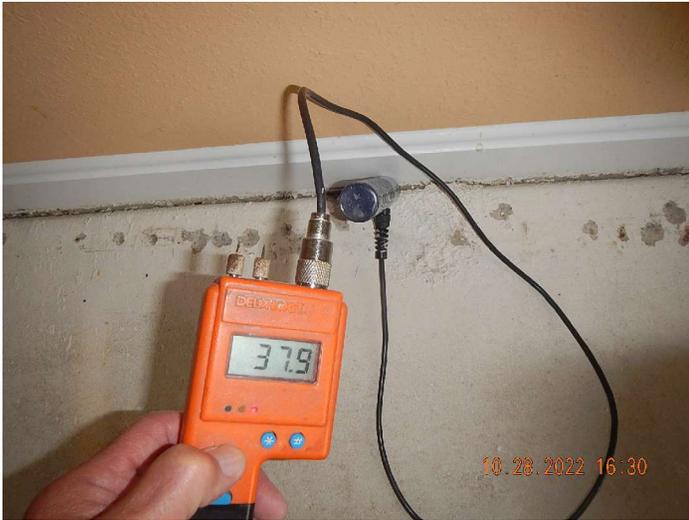
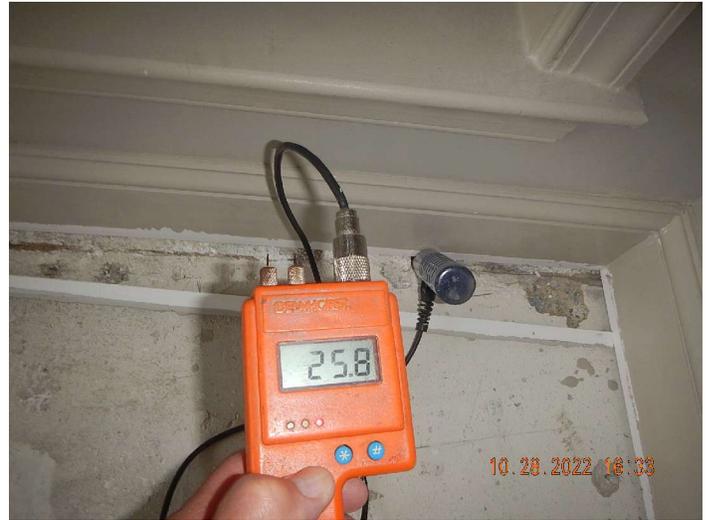
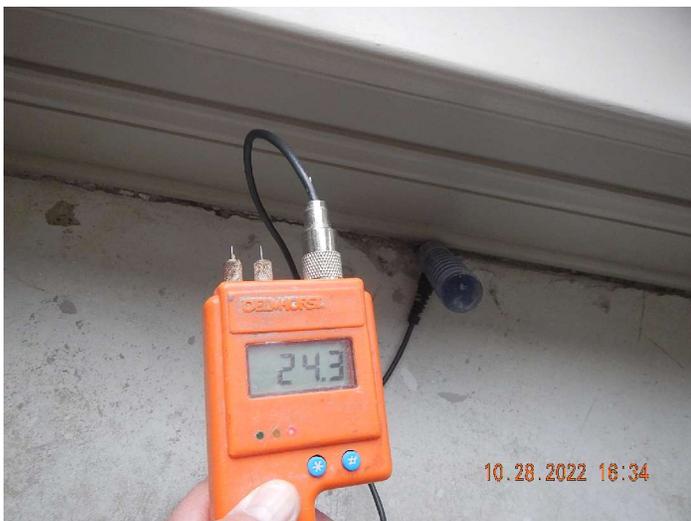
P-4d Excessive Moisture at Slab-to-Foundation Wall Juncture

Wet conditions were consistently measured at the juncture between the floor slab and foundation walls around the house, suggesting this area had remained consistently wet, as from a recent water exposure. Normally this space is found to be no more than dry-to-damp. This finding supports a water exposure mechanism that involved having water come up from below the slab, wet the top of the slab and was available to flow under the vinyl plank flat and wet the bottom of the walls.

Normal moisture concentration of building materials is less than 15%. Moisture concentrations at or above 20% are considered wet.

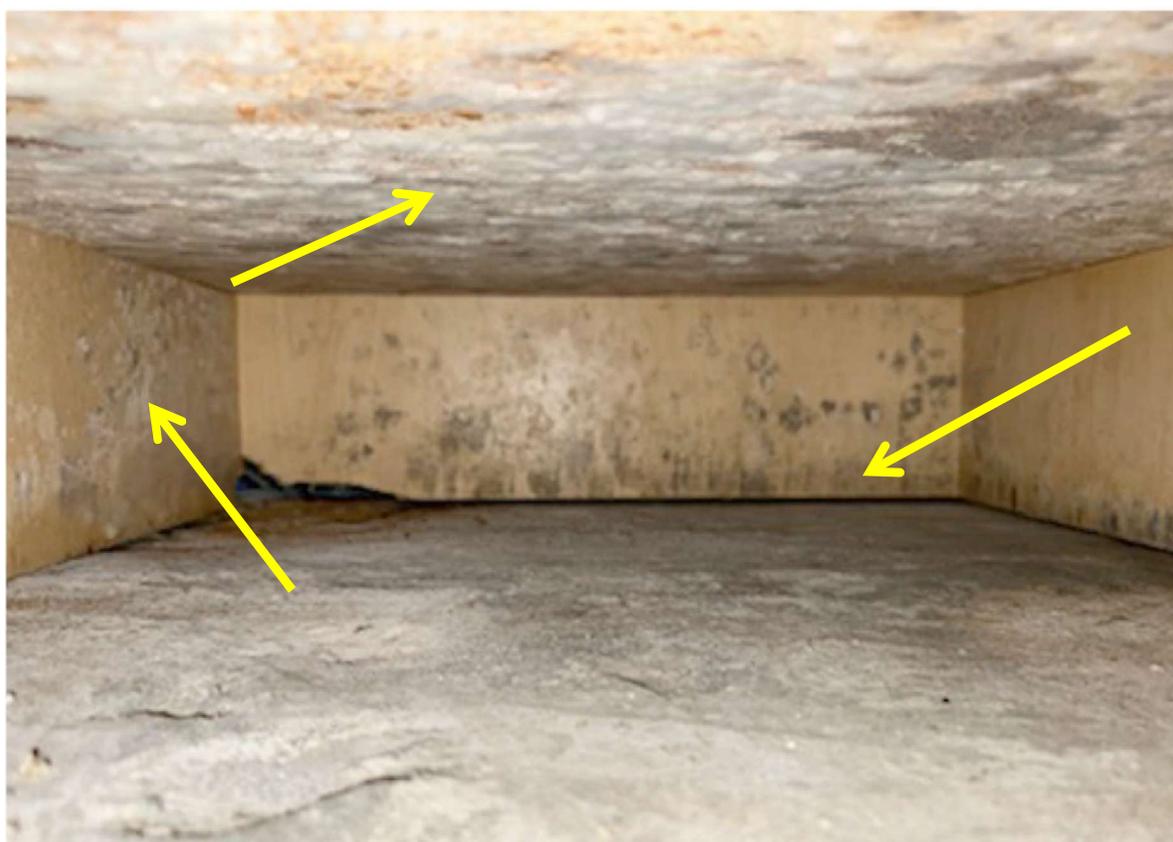
P-4e Suspected Mold Growth Under the Kitchen Cabinet Above the Leak

During their mold abatement work, Core24 observed an extraordinary amount of suspected mold growth on the bottom of the Kitchen cabinet that vertically aligned with the plumbing work Messina had performed below the slab to connect the original water supply and drainpipes to new pipes needed to relocate the Kitchen Island. As seen in Attachment P-4e, the space below this cabinet seemed to have achieved conditions akin to a mold incubator (damp and warm). Nowhere else in the house was such concentrated and diverse suspected mold growth observed. This area needed to have achieved some combination of wetter and warmer conditions than elsewhere in the house.

Core24 discovered and then cleaned the suspected mold.

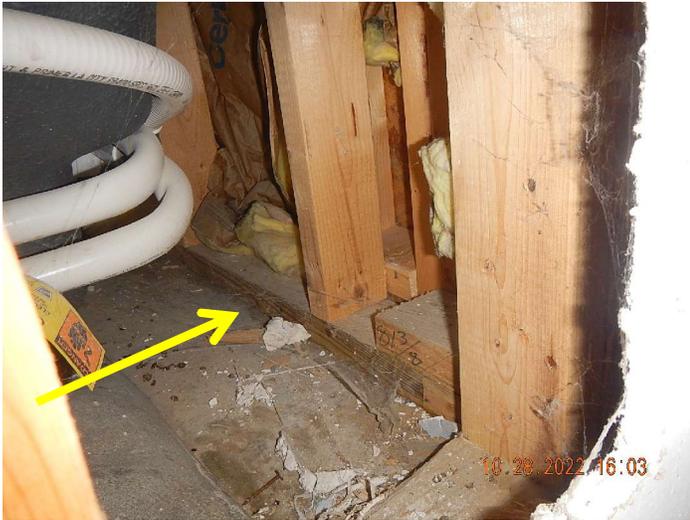
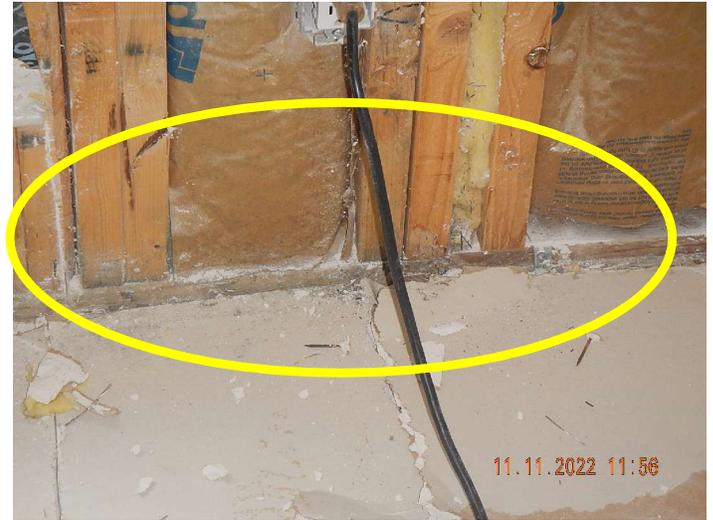
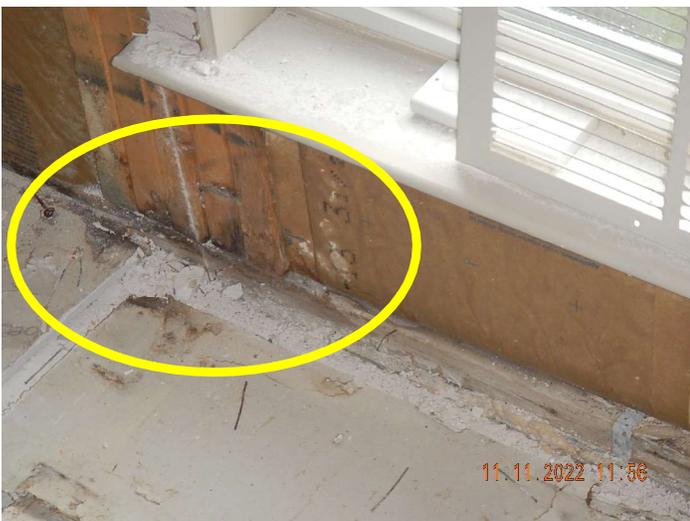
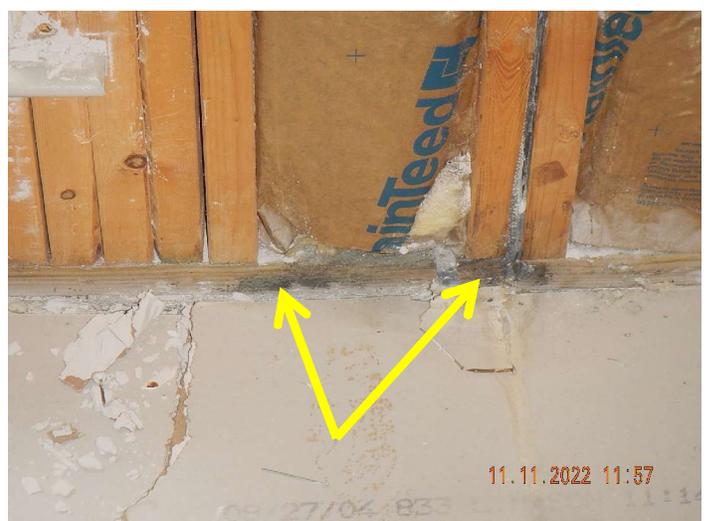
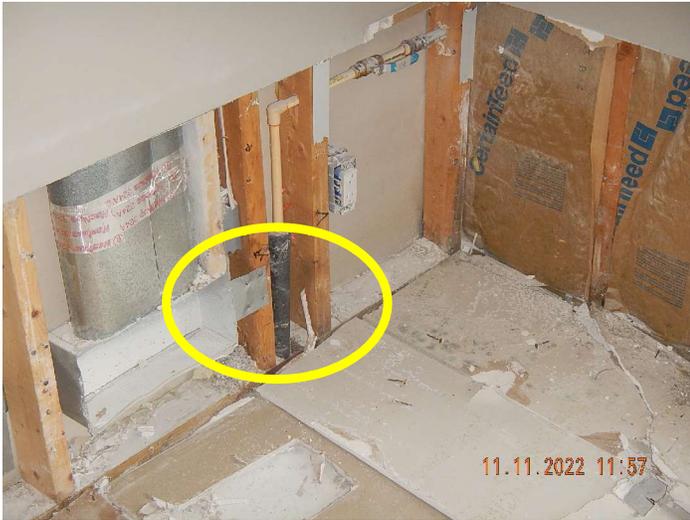
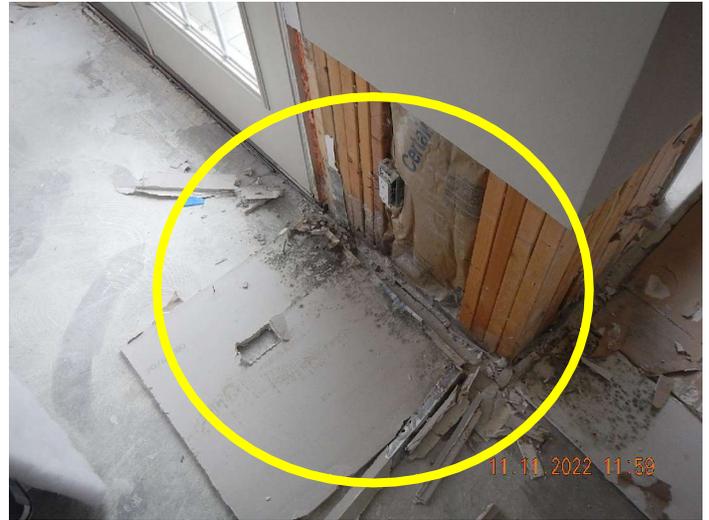
P-4f Concealed Areas of Water Exposure

With the drywall removed indications of water exposure to the bottom of the framed walls were apparent.

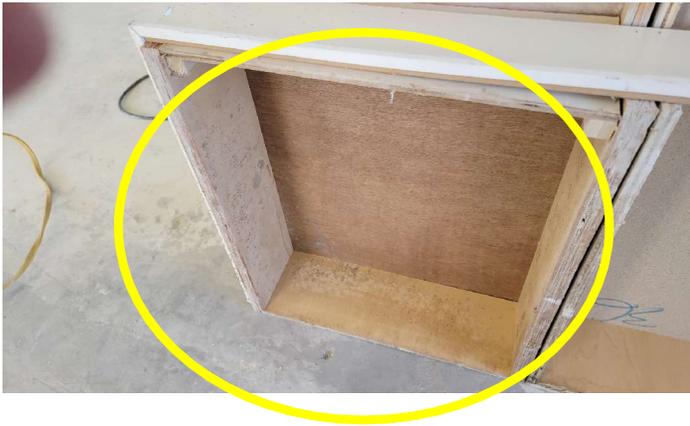
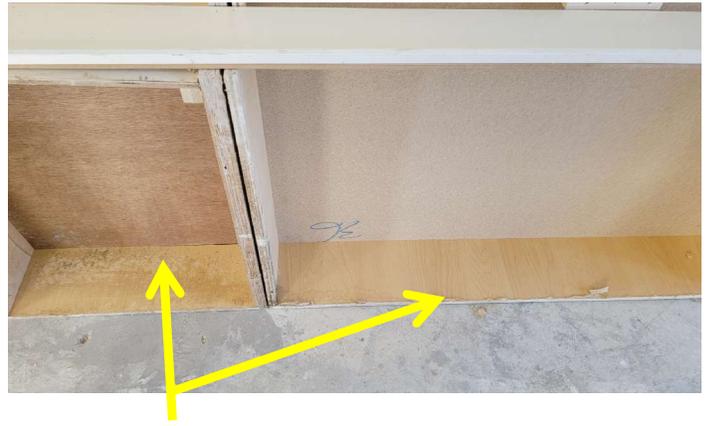
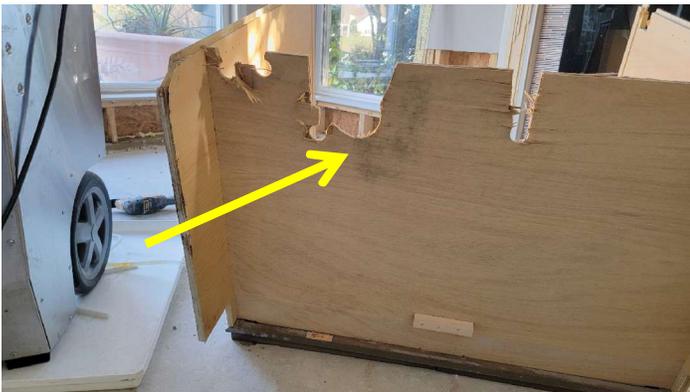
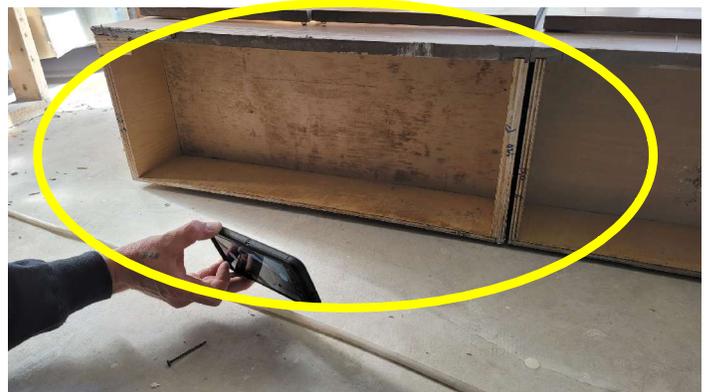
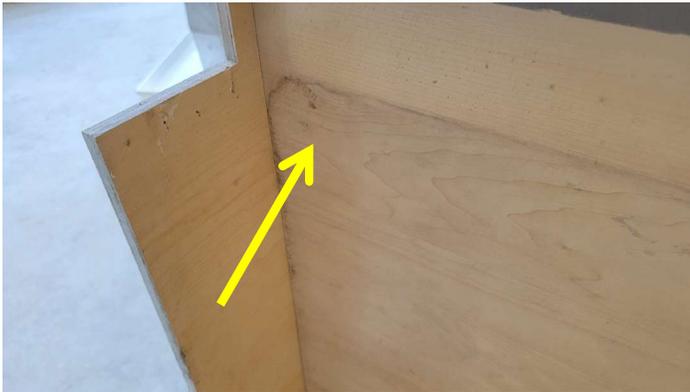
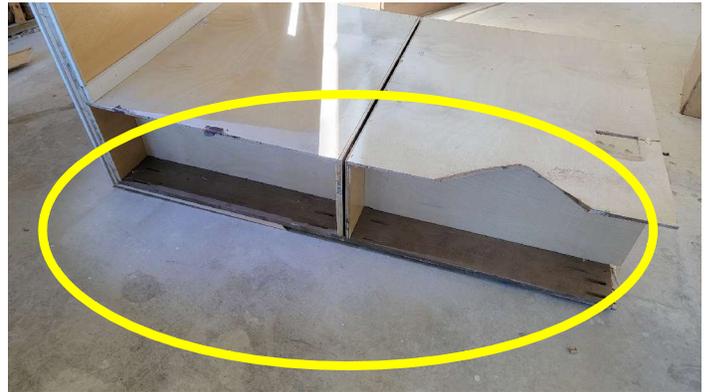
P-4g Cabinet Damage

Between Cogent and Core24, the bottoms, sides and backs of all cabinets in the house were observed with water damage and/or suspected mold growth. See Attachment P-4g. These conditions were observed throughout the house to a degree sufficient to require base cabinet replacement.

Water damage and suspected mold growth was observed under the cabinets. Unfortunately, the wood used to build the cabinets is not water tolerant.
