February 23, 2023

Reference: Water Damage Causation Analysis – 34280 Capstan Lane, Rehoboth Beach, Delaware 19958

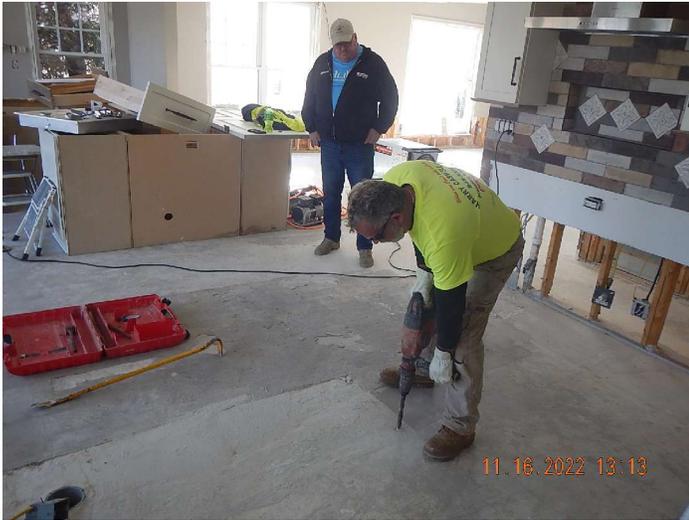
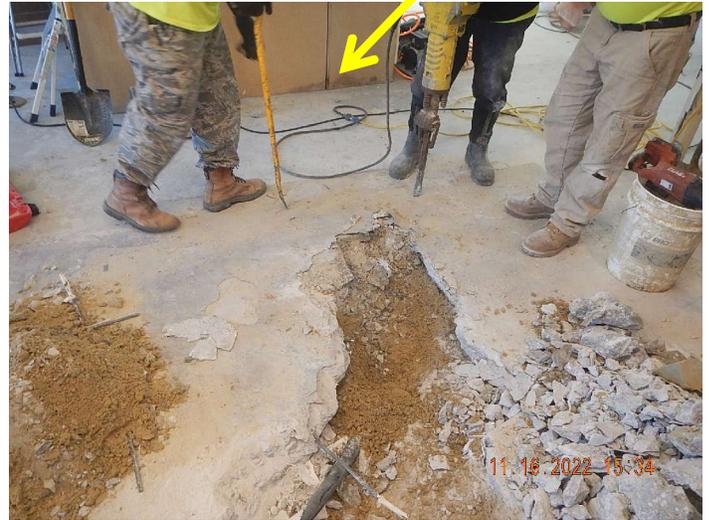
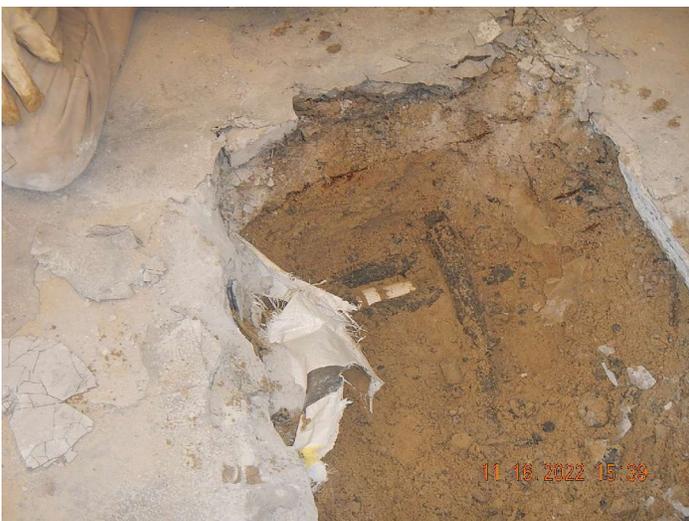
P-5 Leak Source Identification

On October 16, 2022, plumbers from Harry Caswell, Inc., opened the Kitchen floor slab below and nearby the new Kitchen Island to expose the juncture between the original CPVC and new polyethylene water supply piping.

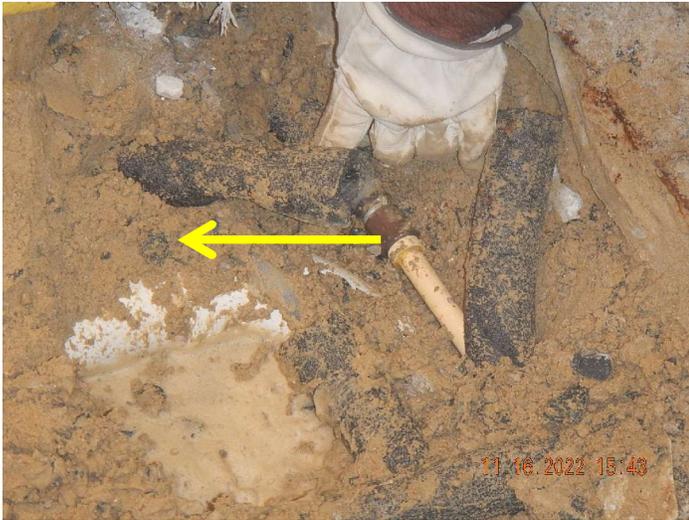
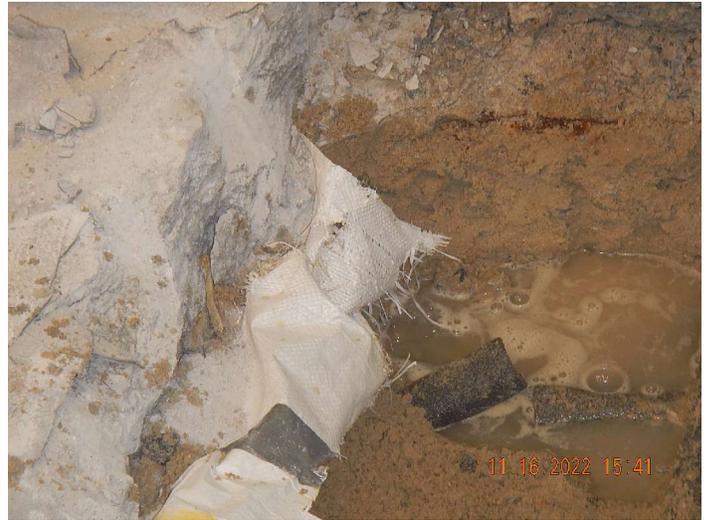
Harry Caswell, Inc., a plumbing contractor not involved in previous work at the Property, was hired to open the concrete floor slab, expose the plumbing in this area, and find and repair the leak. The water leak source was found on November 16, 2022. The water leak originated from a split in the brass adapter that joined the original CPVC hot-water Kitchen supply pipe to new polyethylene pipe. Messina installed this plumbing to relocate the Kitchen Island from its original to its new location. The cold-water system was found not to be leaking. See Attachment P-5 for photographs of the slab removal, leak detection and plumbing repair. Note that a video of the leak from the adapter was made and is on file with Cogent. Analysis of the video suggests that the adapter leak rate was in the range of 3 to 5 seconds per cup of water. This equates to 1.35 GPM to 0.75 GPM.

At the time of the work, Mr. Caswell stated, that based on his experience, the adapter split was caused by the excessive use of pipe thread sealing tape and/or over-tightening the polyethylene pipe fitting into the adapter. He went on to say that brass fittings split or break right after excessive force is applied and do not fail at some later time. Note that Cogent has retained the split adapter as part of the project file.

The left photograph shows the transition from the original CPVC (ivory colored pipe) to polyethylene pipe as it was uncovered. The arrow shows the orientation of the split in the adapter and the direction the water sprayed when the hot water was turned on.

The space around the fittings quickly filled with water.

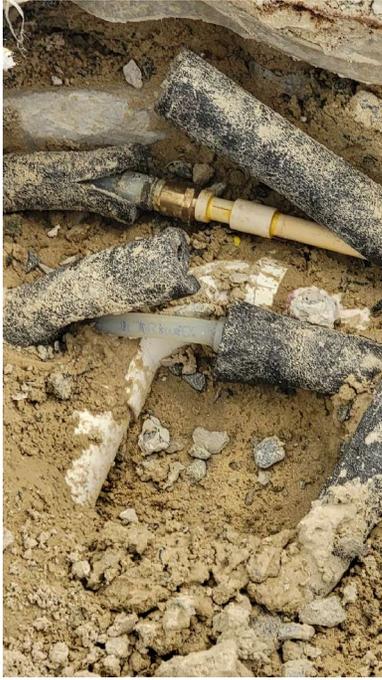
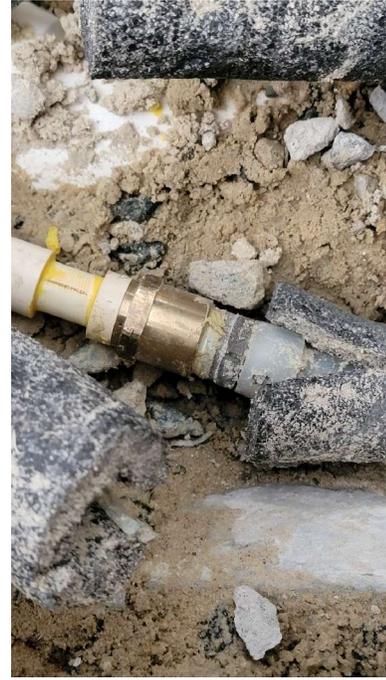
The repaired fittings and the surrounding soil were observed on October 17, 2022, to assure that there were no leaks in this area and that the soil was beginning to dry. The pipe at the bottom of the left photograph is the cold-water supply pipe that was found not to be leaking when the floor was opened.

Note that the repaired piping has been in service without any report of leaks since the time of the Caswell repair.

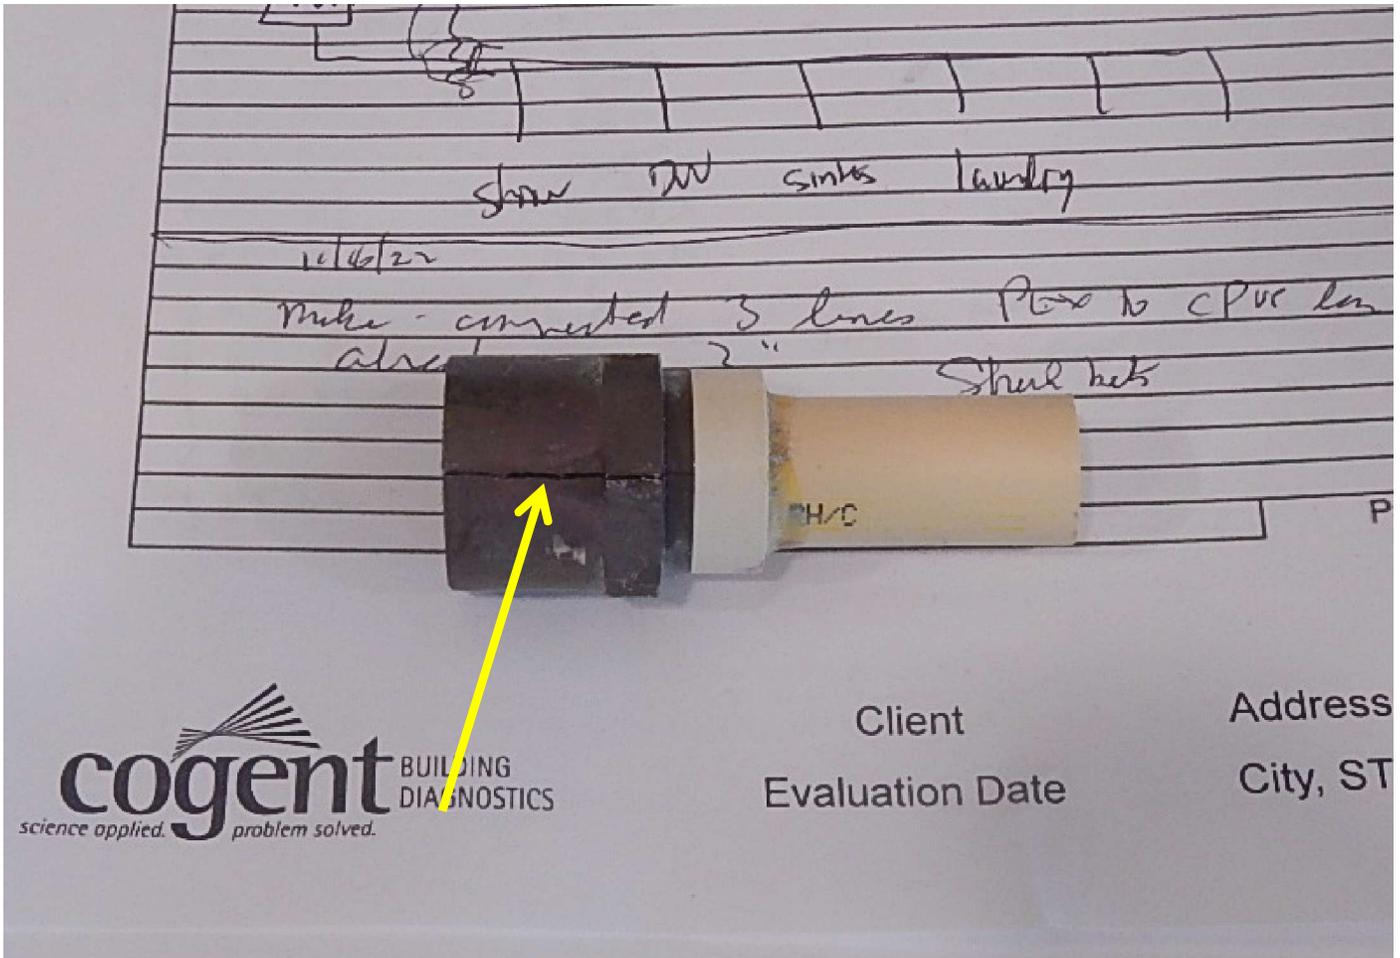
1. The water leak is the result of the use of improper installation methods by the plumber, Charles Messina, who applied an excessive amount of sealing tape and/or over-tightened a brass adapter in the hot water supply pipe to the Kitchen sink.

2. Under this stress, the adapter split open. When the hot water was turned on just after the Kitchen sink was installed, the adapter split released water under the concrete floor slab. This unchecked flow of water accumulated under the slab causing the water level to rise up overflowing the slab and wetting the space between the floor slab and vinyl plank flooring. Overflow locations likely included plumbing and electrical openings in the floor and the open joints between the floor slab the foundation perimeter walls that resulted in water exposure to the house structure and contents throughout the house.

The hot water flow goes from right to left in this photograph. The fitting that was over-tightened entered the brass adapter from the left.
