Policy Number: CAAHO3070000561400
 Insured Name: Michael I & Patti B Cheikin
 Address: 34820 Capstan Lane
 Lewes, DE 19958

Policy #	CAAHO3070000561400	Acct #	802C
Policyholder:	Michael I & Patti B Cheikin	Agency:	
Address:	34820 Capstan Lane Lewes, DE 19958 -	Policyholder's Phone:	(610) 639-6034
Date Requested:	9/25/2019	Inspector ID	520

EXTERIOR OBSERVATION REPORT

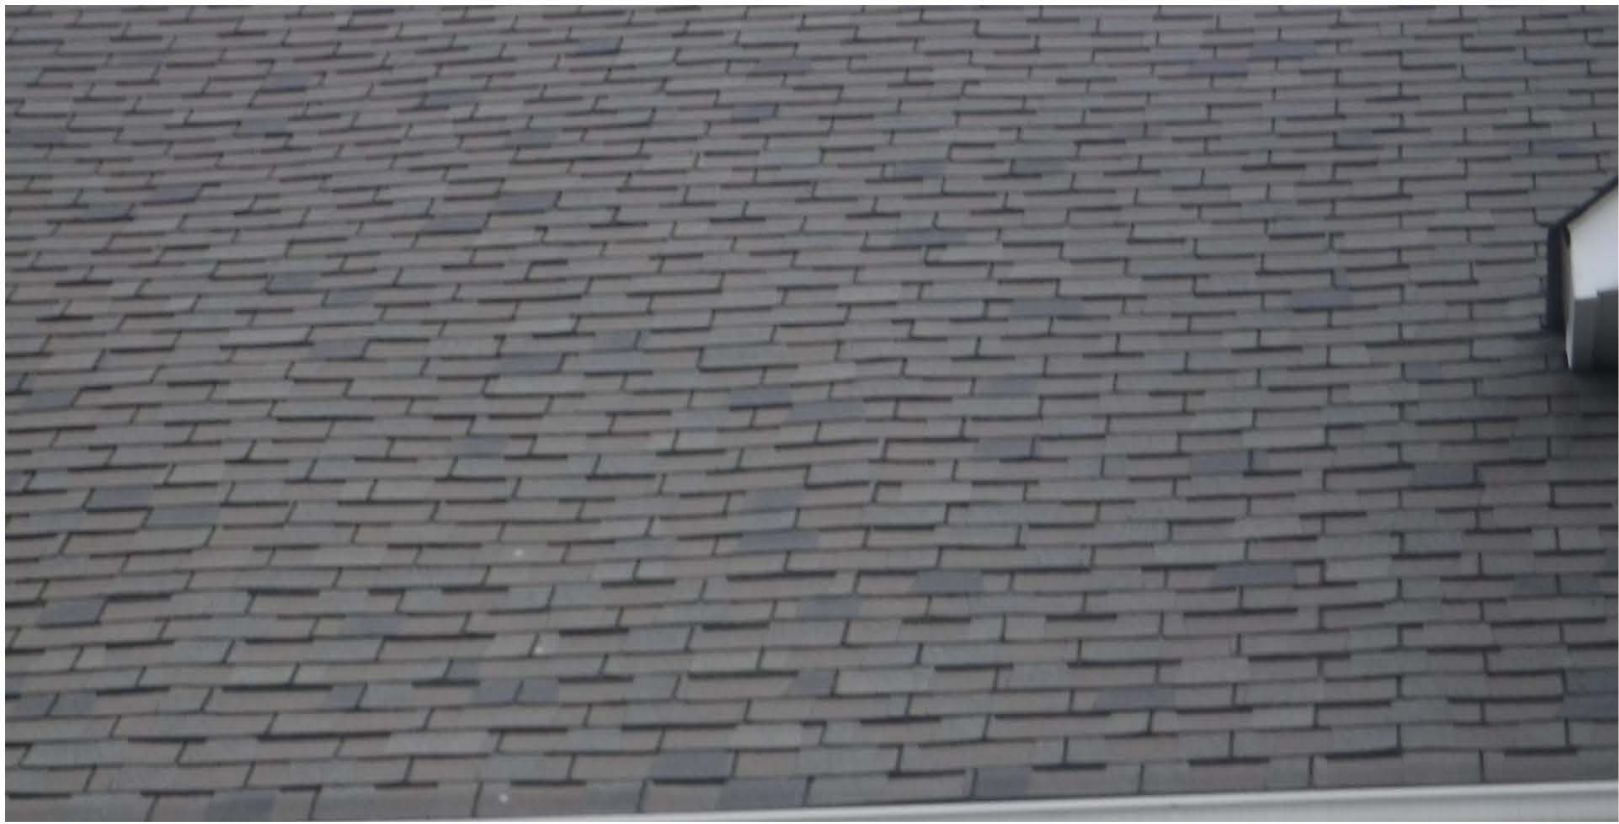
gable roof with asphalt shingles in good condition. 2 car attached garage. no hurricane protection
