| Job Name: 36840 Red Berry Rd. Delmar, DE | Inspection Date: 1/23/2020 |

| Main Roof | Material: Shingles/Metal Roof | Roof Design:Hip Roof |

Below are images and descriptions of the issues caused by incorrectly installed shingles, siding, soffit and fascia.

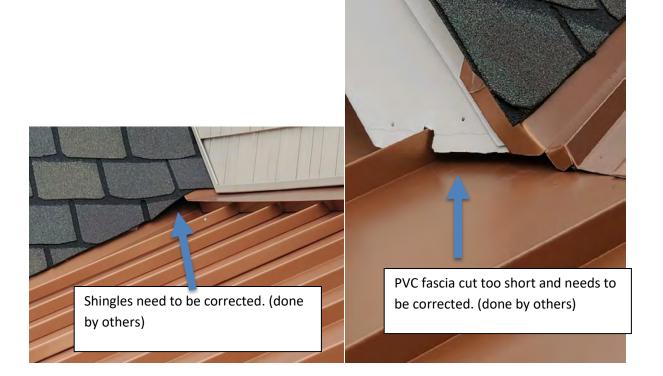
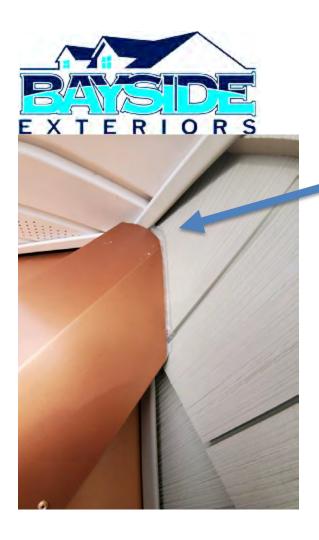
Ridge Cap cut back from the wall by siding installers. (Done by Others)

Can be corrected for \$160.00

Listing of repairs needed: Replace Hip cap that was cut short by siding installers \$160.00. Soffit, fascia, shingles and siding was installed short leaving gaps above the metal roofing.(these items were installed by others and needs to be corrected)

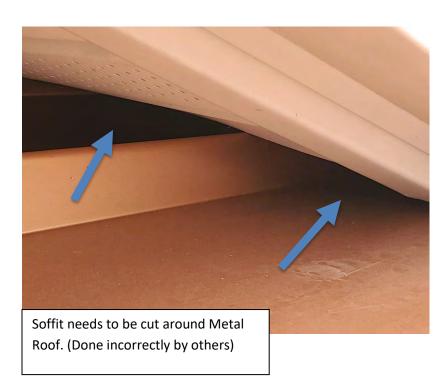
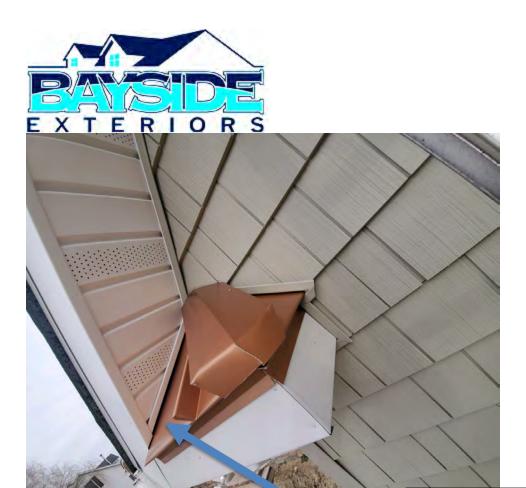
J-Channel needs to be tight to the metal roof to keep water and animals out. (done by others)

There is nothing wrong with how the metal meets the shingles. (Shingles were installed by others after metal roof was installed)

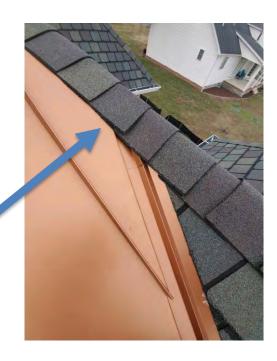
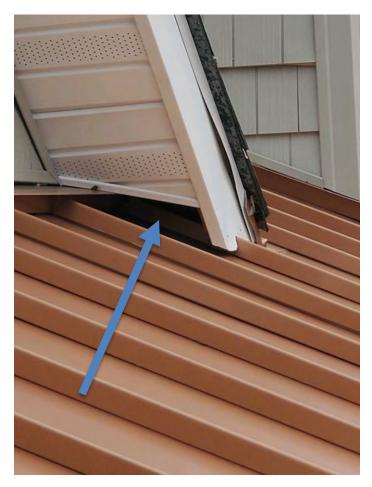
Soffit and J-Channel needs to be cut around metal roof to close gap. This is needed to keep water and animals out.(done by others)

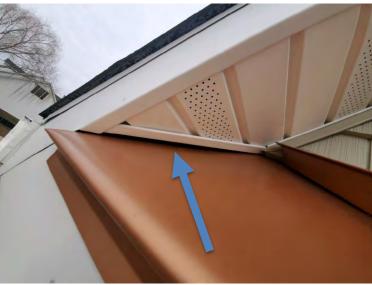
J-Channel needs to be tight to the metal roof to keep water and animals out. (done by others)
