CHEIKIN-WTR-102522 Report

Water

34820 Capstan Lane, Lewes, DE, USA

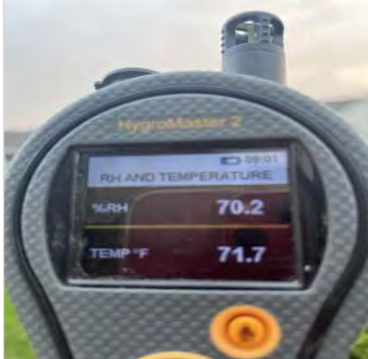
#	Time	Relative Humidity	Specific Humidity	Air Temperature	Notes & Photos
1	Oct 25, 5:50 PM	70.2%	81.6 gpp	71.7°F

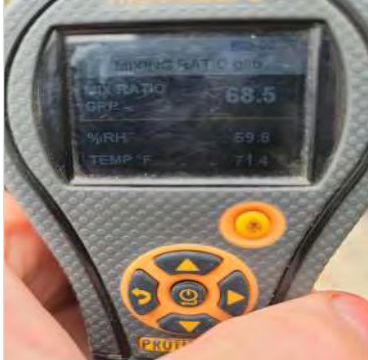
2	Oct 31, 10:27 AM	59.8%	68.6 gpp	71.4°F

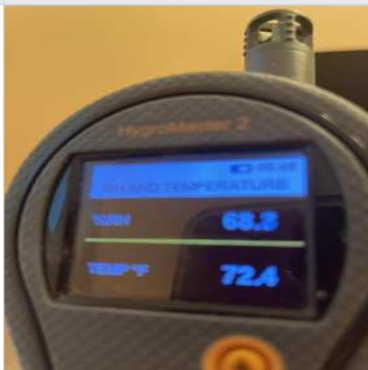
#	Time	Room	Relative Humidity	Specific Humidity	Air Temperature	Notes & Photos
1	Oct 25, 5:37 PM	Office	68.8%	81.9 gpp	72.4°F

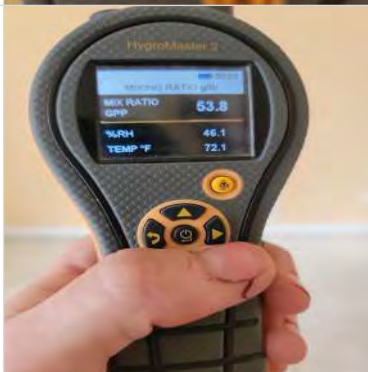
2	Oct 31, 10:13 AM	Office	72.1%	33.1 gpp	46.1°F

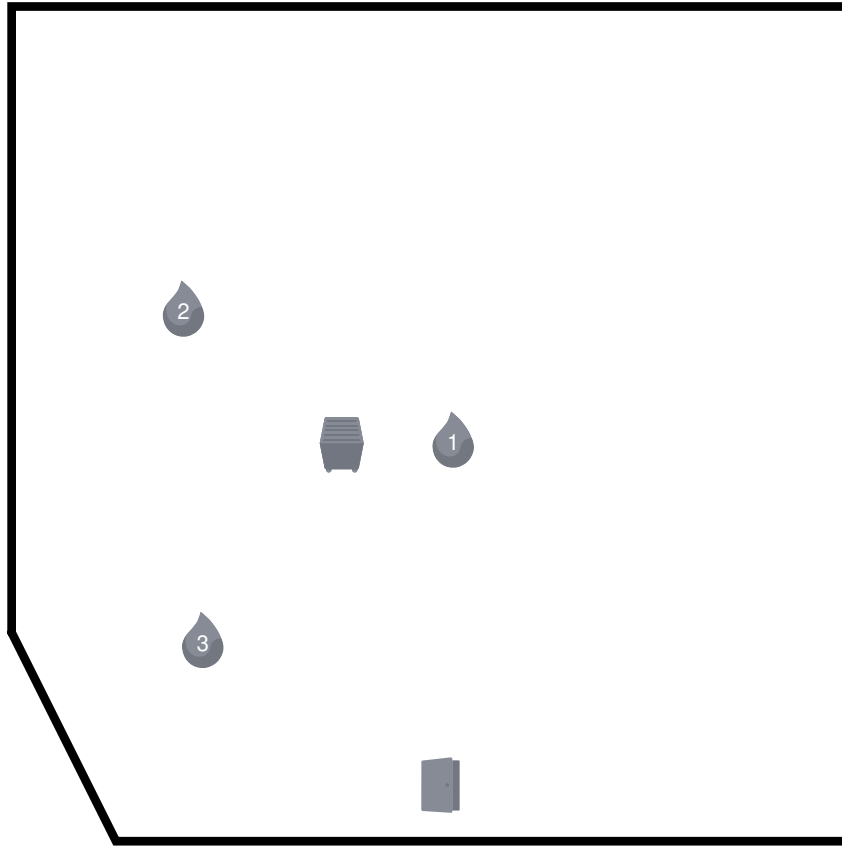
Affected Area: Office

1.1: Carpet		31.3%

#	Time	Meter	Moisture Content	Surface Temperature	Notes & Photos
1	Oct 25, 5:44 PM	Protimeter 100%	31.3%

Removed
Protimeter 100% Dry Standard: 13.2%

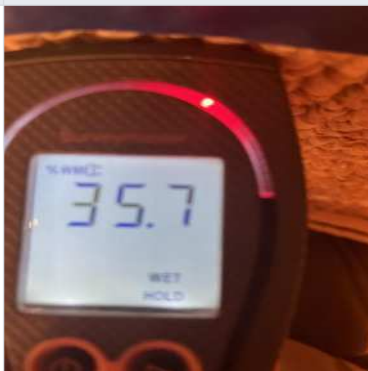
Point 2:

2.1: Carpet Protimeter 100% Dry Standard: 13.2% 35.7%

Oct 25 Oct 26 Removed
#	Time	Meter	Moisture Content	Surface Temperature	Notes & Photos
1	Oct 25, 5:45 PM	Protimeter 100%	35.7%

2	Oct 31, 10:54 AM				Material Removed: Material removed
2.2: Concrete Delmhorst Scan 300 99.9

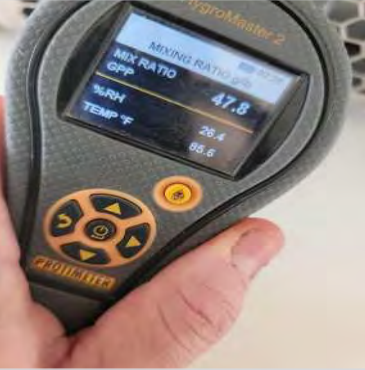
Dehumidifier: Phoenix 200HT [4029970] (A1477566)

#	Time	Relative Humidity	Specific Humidity	Air Temperature	Grain Depression	Hours Running	Notes & Photos
2	Oct 31, 10:15 AM	85.6%	17.4 gpp	26.4°F	16 gpp

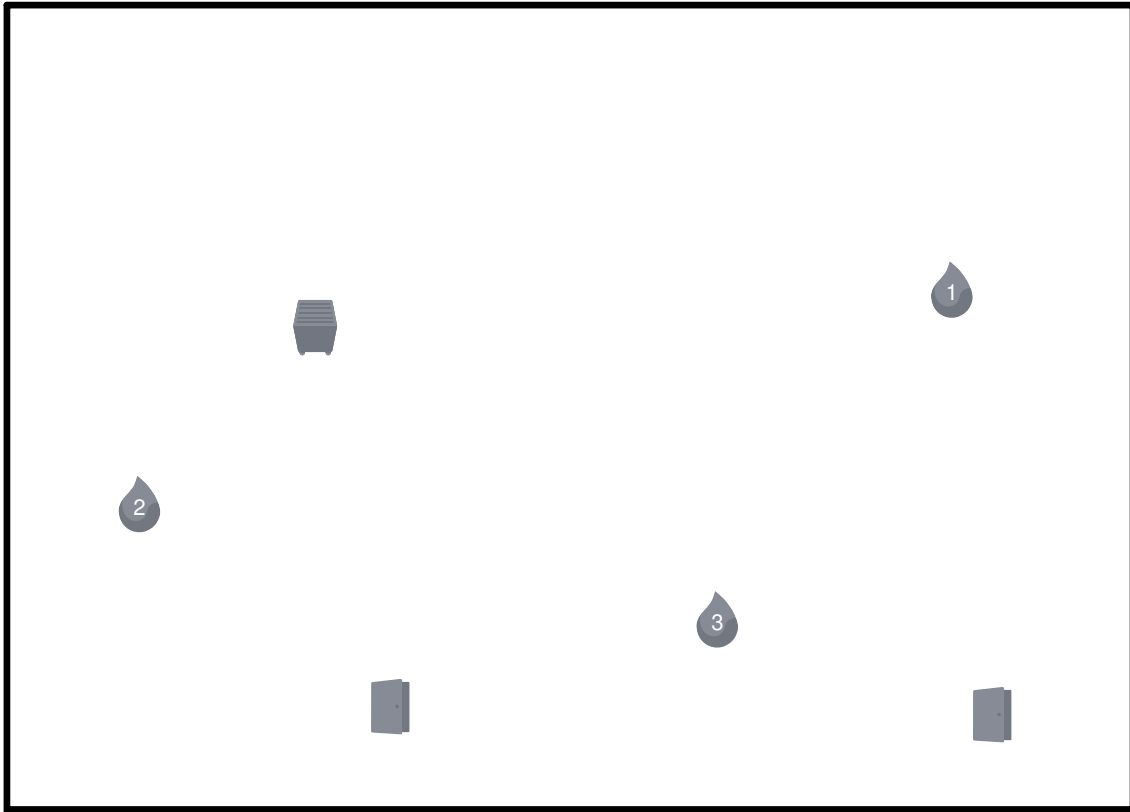
Affected Area: Bedroom - Master

1.1: Carpet					 Removed
Protimeter 100% Dry Standard: 13.2%					
#	Time	Meter	Moisture Content	Surface Temperature	Notes & Photos
1	Oct 25, 5:29 PM	Protimeter 100%	24.4%

#	Time	Meter	Moisture Content	Surface Temperature	Notes & Photos
1	Oct 25, 5:31 PM	Protimeter 100%	99.9%		
2	Oct 31, 11:05 AM	Delmhorst Scan 300	99.9	74.7°F	
3	Oct 31, 11:04 AM				Material Removed: Removed carpet

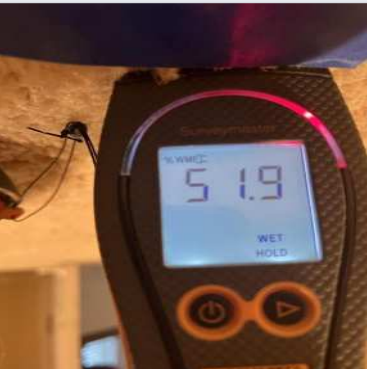
Point 3:

#	Time	Meter	Moisture Content	Surface Temperature	Notes & Photos
<p>3.1: Carpet 51.9%</p> <p>Protimeter 100%</p> <p>Dry Standard: 13.2%</p> <div style="text-align: center;"> Oct 25 Oct 26 </div> <div style="text-align: right; border: 1px solid black; padding: 5px;"> X Removed </div>					
1	Oct 25, 5:33 PM	Protimeter 100%	51.9%

2	Oct 31, 11:04 AM				Material Removed: Removed carpet
<p>3.2: Concrete 73</p> <p>Delmhorst Scan 300</p> <div style="text-align: center;"> Oct 31 Nov 1 </div> <div style="text-align: right; border: 1px solid black; padding: 5px;"> ? Unknown </div>					
#	Time	Meter	Moisture Content	Surface Temperature	Notes & Photos
1	Oct 31, 11:05 AM	Delmhorst Scan 300	73	75°F

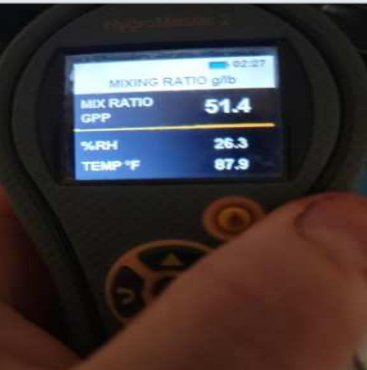
Dehumidifier: Drieaz Evolution (80265)

#	Time	Relative Humidity	Specific Humidity	Air Temperature	Grain Depression	Hours Running	Notes & Photos
1	Oct 31, 10:17 AM	26.3%	51.6 gpp	87.9°F	1 gpp

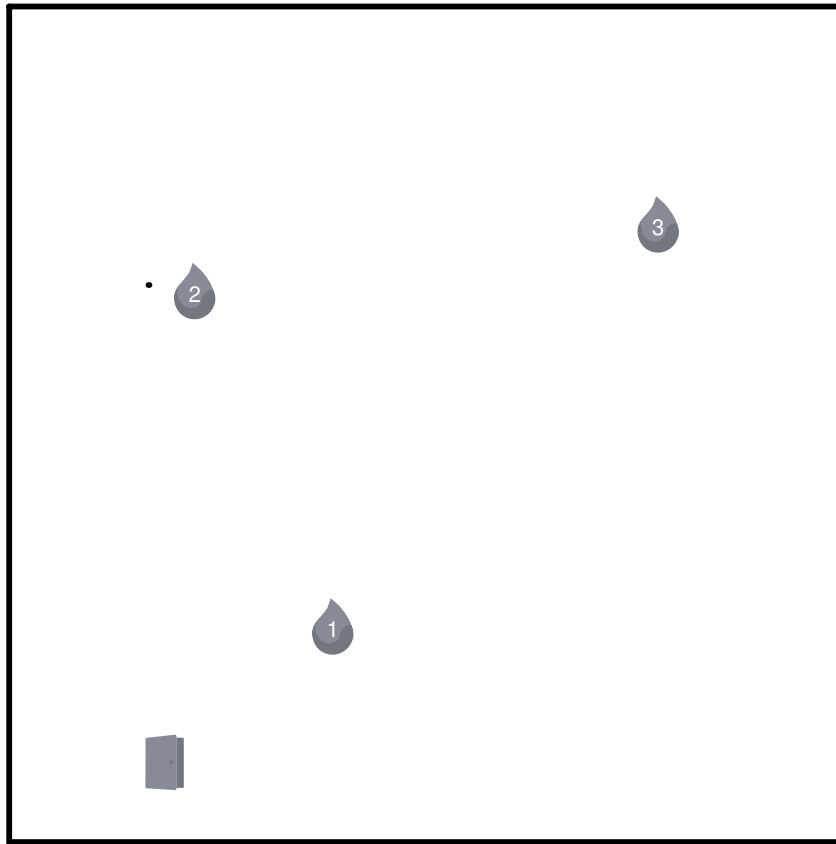
Affected Area: Bedroom

1.1: Carpet		45.9%

#	Time	Meter	Moisture Content	Surface Temperature	Notes & Photos
1	Oct 25, 5:17 PM	Protimeter 100%	45.9%

Removed	
Protimeter 100% Dry Standard: 13.2%

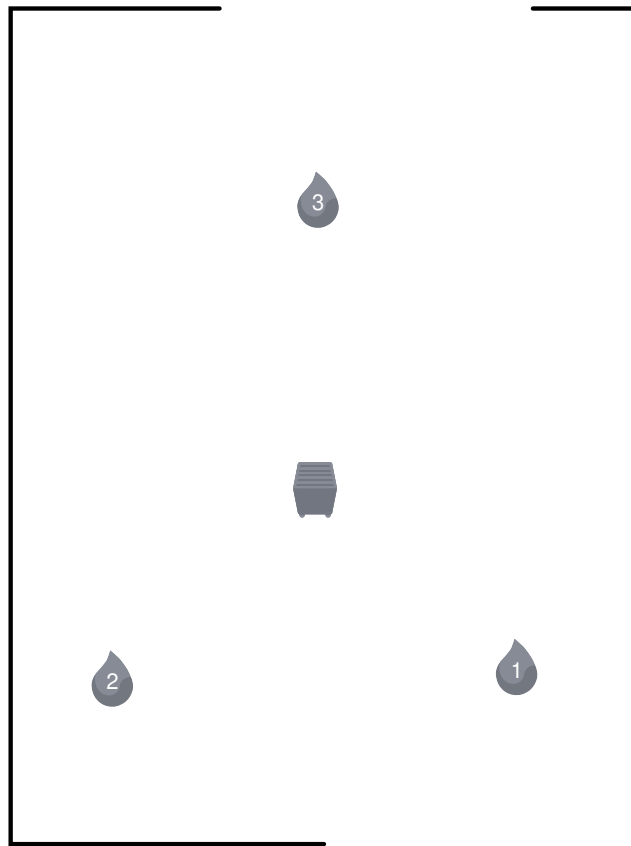
Affected Area: Living Room

#	Time	Meter	Moisture Content	Surface Temperature	Notes & Photos
1	Oct 25, 6:19 PM	Protimeter 100%	99.9%

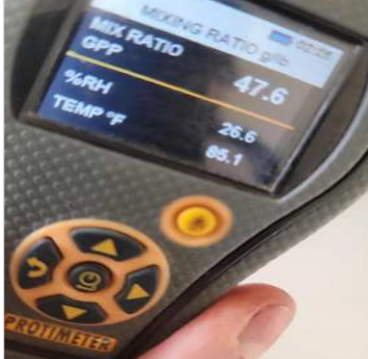
Dehumidifier: Phoenix R200 Dehumidifier [4027000] (AR002DH)

#	Time	Relative Humidity	Specific Humidity	Air Temperature	Grain Depression	Hours Running	Notes & Photos
1	Oct 25, 6:53 PM	29.5%	65 gpp	91.5°F	14 gpp		 
2	Oct 31, 10:16 AM	26.6%	47.7 gpp	85.1°F	3 gpp

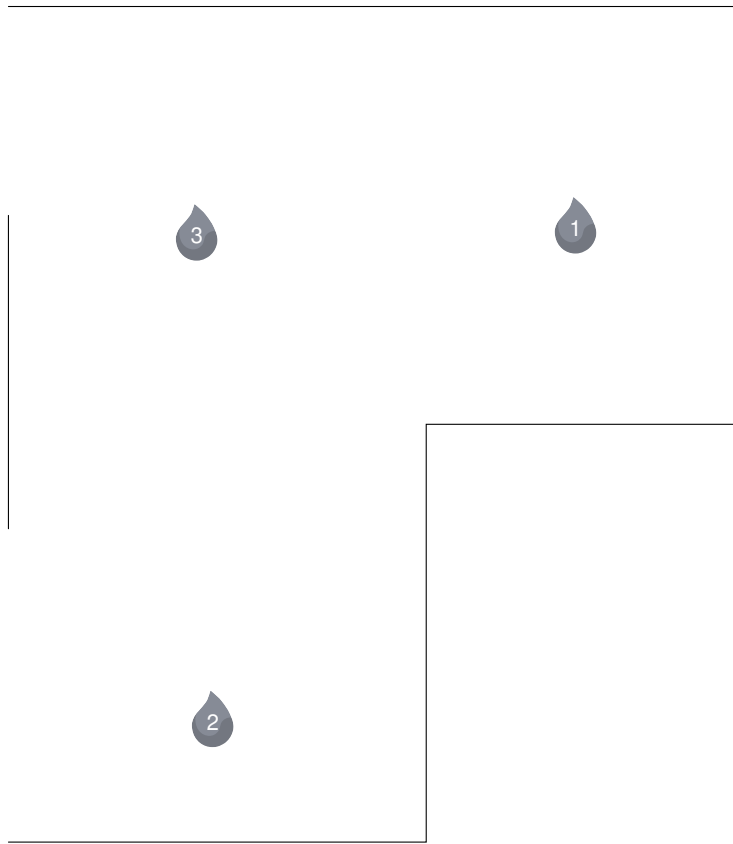
Affected Area: Kitchen

1.1: Laminate					 Removed
Protimeter 100% Dry Standard: 13.2%					
#	Time	Meter	Moisture Content	Surface Temperature	Notes & Photos
1	Oct 25, 6:23 PM	Protimeter 100%	20.2%

2.1: Concrete <u>Protimeter 100%</u> Dry Standard: 13.2%					 Still Wet
#	Time	Meter	Moisture Content	Surface Temperature	Notes & Photos
1	Oct 25, 6:23 PM	Protimeter 100%	99.9%		
2.2: Concrete <u>Delmhorst Drywall 6%</u>					 Unknown
#	Time	Meter	Moisture Content	Surface Temperature	Notes & Photos
1	Oct 31, 11:11 AM	Delmhorst Drywall 6%	43.3%	74.7°F

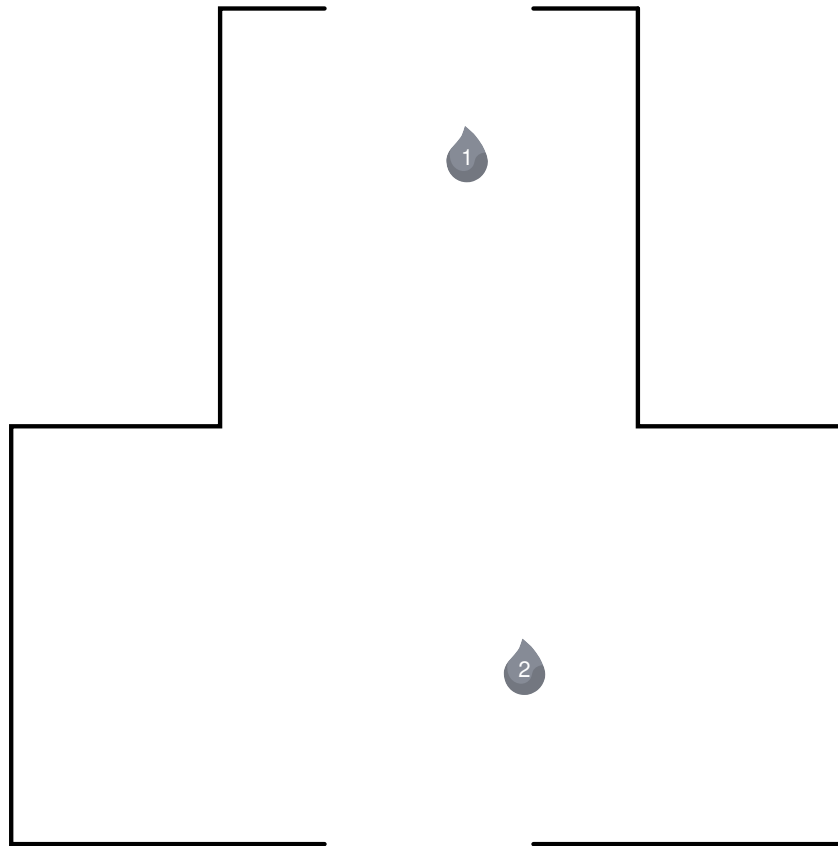
Affected Area: Laundry Room

#	Time	Meter	Moisture Content	Surface Temperature	Notes & Photos
1	Oct 25, 6:26 PM	Protimeter 100%	20.7%

#	Time	Meter	Moisture Content	Surface Temperature	Notes & Photos
2	Oct 31, 11:12 AM				Material Removed: Removed laminate
1.2: Concrete			35.1%		Unknown
<u>Delmhorst Drywall 6%</u>					
				Oct 31	Nov 1
#	Time	Meter	Moisture Content	Surface Temperature	Notes & Photos
1	Oct 31, 11:13 AM	Delmhorst Drywall 6%	35.1%	75°F

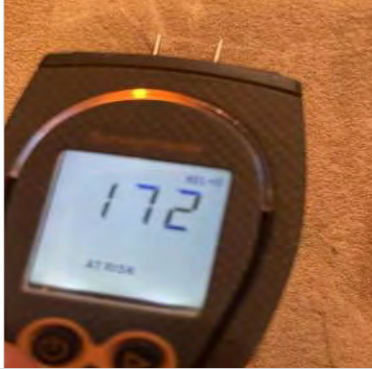
Point 2:

2.1: Laminate			17.2%		Removed
<u>Protimeter 100%</u>					
Dry Standard: 13.2%					
				Oct 25	Oct 26
#	Time	Meter	Moisture Content	Surface Temperature	Notes & Photos
1	Oct 25, 6:27 PM	Protimeter 100%	17.2%

2	Oct 31, 11:13 AM				Material Removed: Removed laminate
2.2: Concrete			42.8%		Unknown
<u>Delmhorst Drywall 6%</u>					
				Oct 31	Nov 1
#	Time	Meter	Moisture Content	Surface Temperature	Notes & Photos
1	Oct 31, 11:13 AM	Delmhorst Drywall 6%	42.8%	75°F
